## XC27x5X Derivatives

16/32-Bit Single-Chip Microcontroller  
with 32-Bit Performance  
XC2000 Family / Base Line

Errata Sheet

V1.5 2013-02

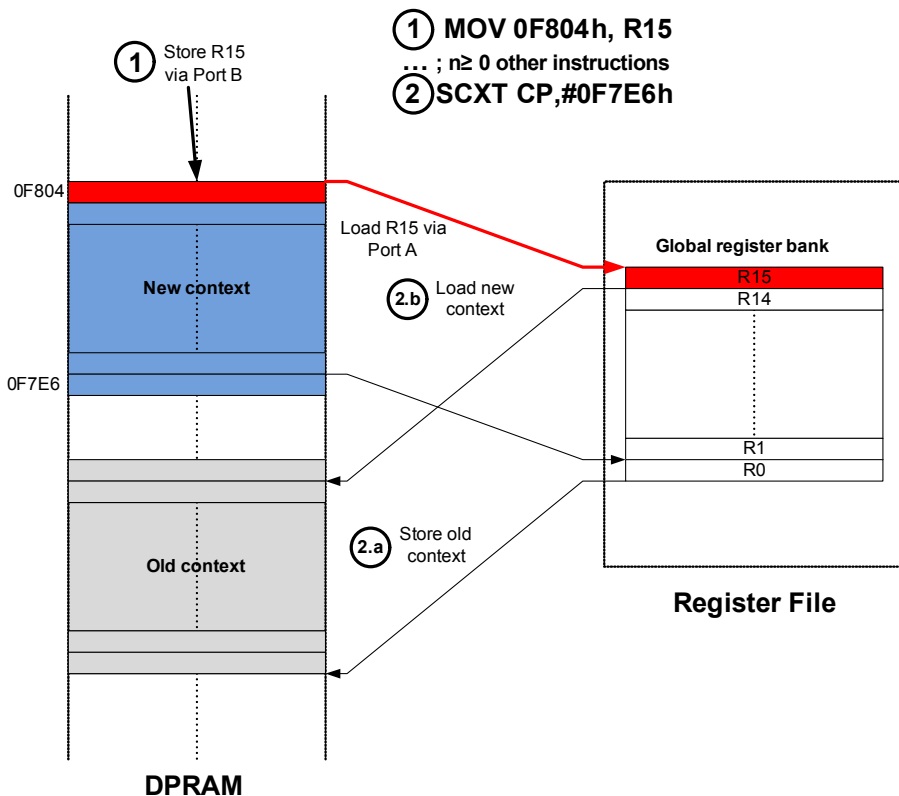
**Figure 1 Context Switch with Pointer Passing in R15**

Under special conditions, undefined data may be read from up to two word locations  $L_1$ ,  $L_2$  in the DPRAM (address range  $F600_H \dots FDFH_H$ ).

In this case, the contents of Rx may be incorrect.

This scenario may typically occur at the beginning of interrupt routines when a GPR (e.g. R15 used as user stack pointer) is saved into the new GPR context in DPRAM, as shown in the following **Figure 1**.

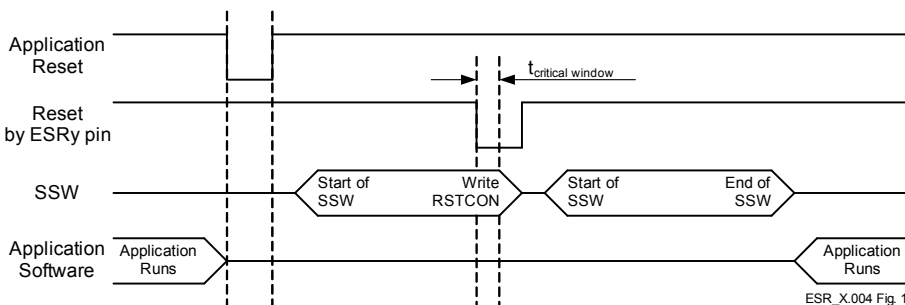
**Figure 2 Critical application reset sequence**

SCU\_RSTCONx registers are reset only by Power-On, but they may be wrongly affected after a second application reset requested by an ESRy pin. This may lead to the SCU\_RSTCONx register values being set to zero, which could unexpectedly disable reset sources within the user application. The conditions which lead to this behavior are:

1. First, an application reset by SW (software), CPU (Central Processing Unit), MP (Memory), WDT (Watchdog Timer) or ESRy (External Service Request y) occurs.
2. Following this, an application reset on an ESRy pin occurs.
3. If the above mentioned ESRy reset occurs during a critical time window of the SSW (startup software), then it's possible that the application will operate with the wrong SCU\_RSTCONx register value. The critical time window occurs when the SSW is writing the SCU\_RSTCONx registers, and at the same time, the ESRy reset request is processed by the reset circuitry. The width of this critical window  $f_{\text{critical window}}$  is less than 13 cycles.

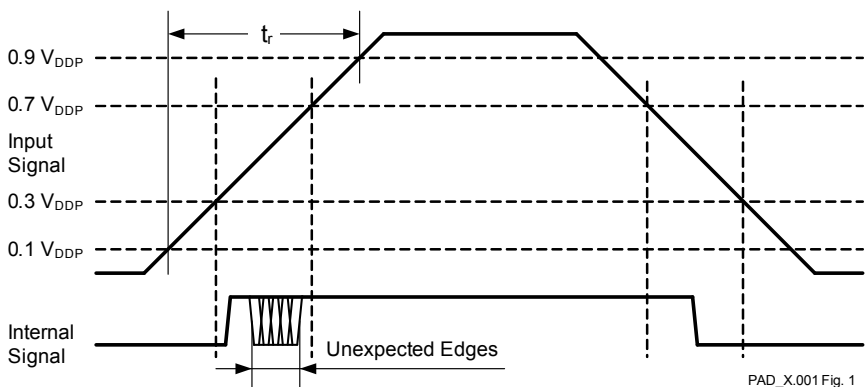
**Figure 3 Example for a Slow Input Signal**

The digital input- and I/O-pins are designed using Schmitt trigger input structures with hysteresis. Even with this structure, it is possible that very slow rising edges may generate spikes, resulting in unexpected additional edges at the input signal.

The next picture **Figure 3** is an example for a slow input signal, with spikes shown on the slow rising input signal.
