Intel[®] 5000 Series Chipset Memory Controller Hub (MCH)

Specification Update

September 2009

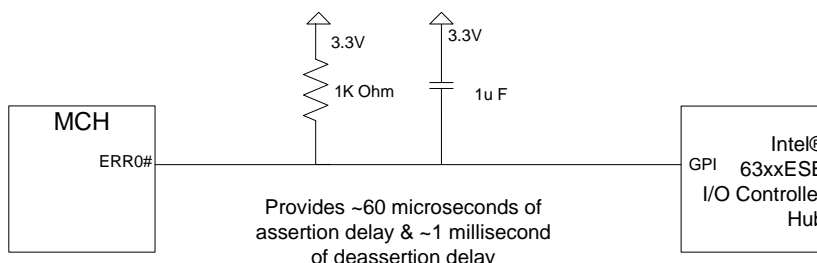
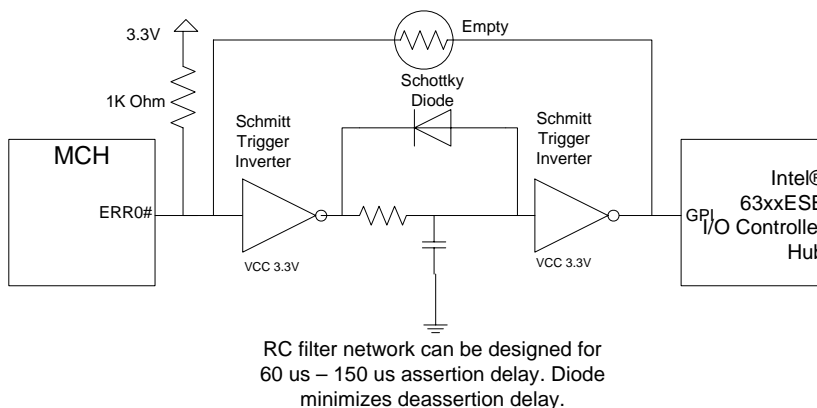
Problem: Any condition routed to MCH ERR[2:0]# output pins for SMI# escalation that would result in data poisoning on FSB will result in a CPU IERR# assertion due to race condition. The race condition exists between poisoned data presented to the FSB by the MCH and the uncorrectable error escalated to SMI# via ERR[2:0]# pins. If the CPU observes an SMI# assertion before the poisoned data is presented to the FSB, the CPU asserts MCERR# followed by IERR#. The CPU expects the SMI# assertion to occur at least 10 BCLKs after the associated MCERR# assertion. Conditions that result in data

Implication: CPU may assert IERR# and cause a system hang before the error may be logged in SMM.

Workaround: The following workarounds have been identified:

1. Log errors upon reboot
 - System components (MCH, CPU, Southbridge) preserve errors across warm resets via sticky error registers
 - Requires a mechanism to reset system upon IERR# (server management controller, depress system reset button, and so forth)
2. Delay SMI# assertion by inserting a 60µs-150µs delay on the ERR0# pin
 - Two recommended circuit solutions (other solutions may be possible):

- Route errors that result in FSB data poisoning to the ERR0# pin (IO4, M2, M4-13, M15)

3. Disable FSB data parity checking on CPU
 - Prevents CPU from asserting MCERR# on poisoned data
