Intel[®] 82579 GbE PHY Specification Update

October 2012
v2.5

Reference Number: 324967-005

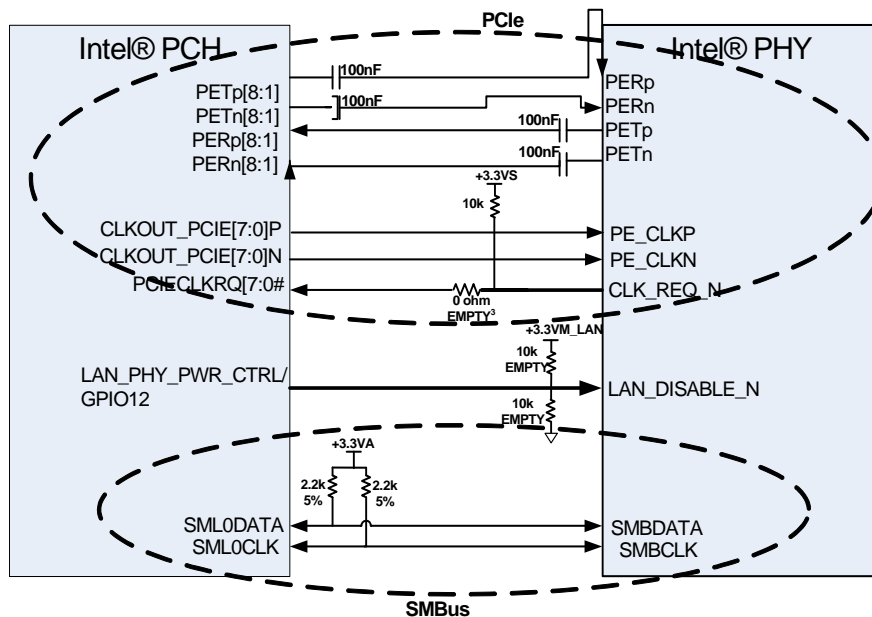
Change: Chapter 2, Figure 2 Intel 6 Series Express Chipset/82579 Interconnects; Chapter 16, Figure 16-9; and Chapter 17, Figure 17-9 should appear as follows:
