Intel[®] Communications Chipset 89xx Series

Specification Update

October 2012

Document Number: 328000-001US

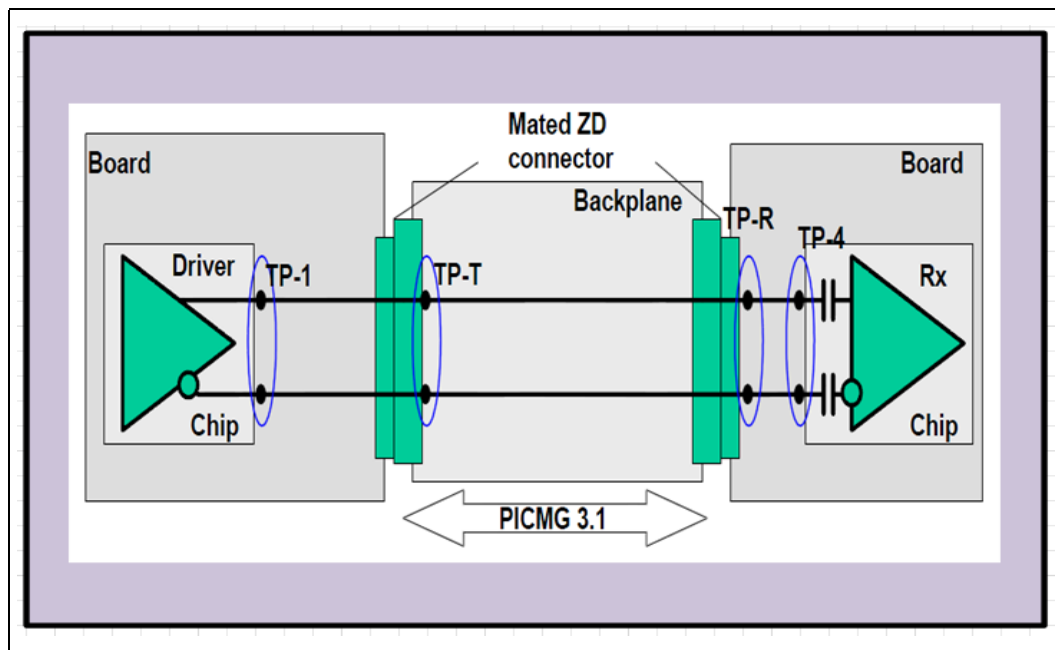
Figure 2. 1000BASE-BX/FC-PI Transmitter Electrical Specifications

75. GbE: GbE Interface Transmit Voltage Level Specification Violation

Implication: Although this is a specification violation, it does not affect the functional operation of the interface.

Workaround: Ensure that the signal routing length from TP-1 to TP-4 is greater than 10". Refer to Intel® Communications Chipset 89xx Series Platform Design Guide (PDG) for maximum routing length. (See Figure 2).
