Intel[®] Atom[™] Processor E6xx Series

Specification Update

May 2013

Revision 016

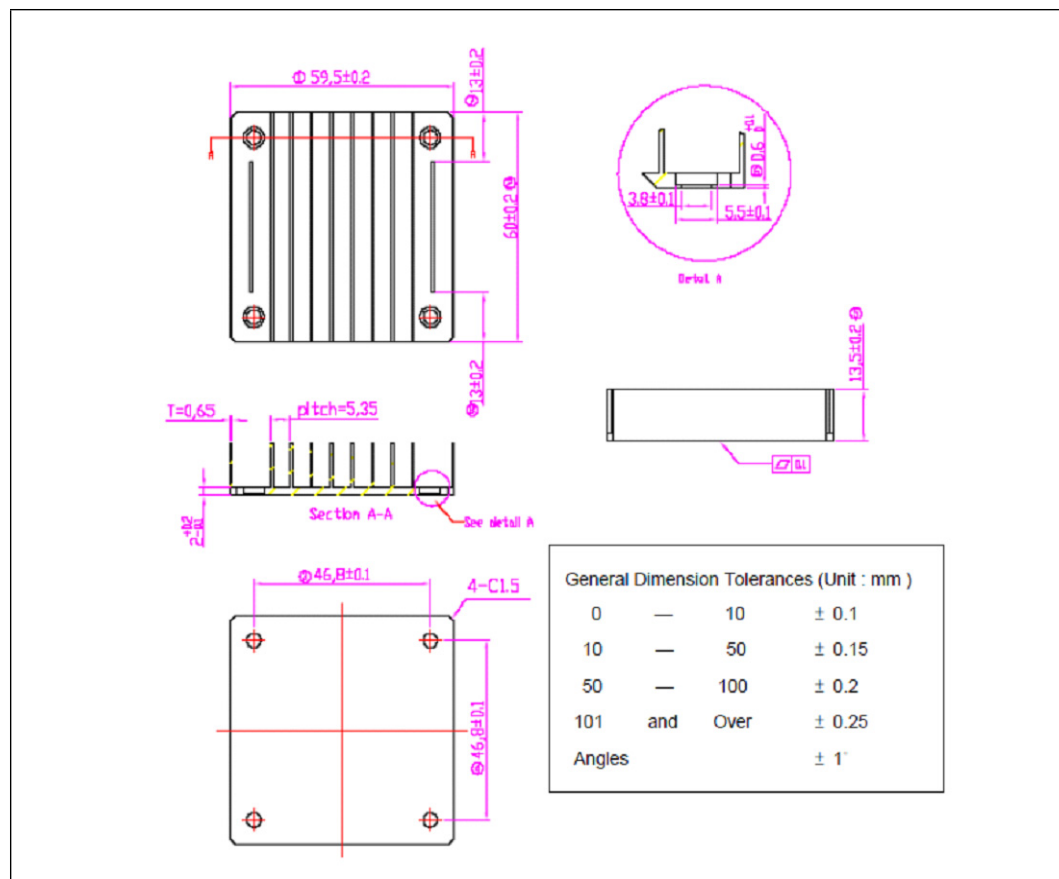
Figure 10. 1U Natural Convection Heatsink Mechanical Drawing

Old Text:

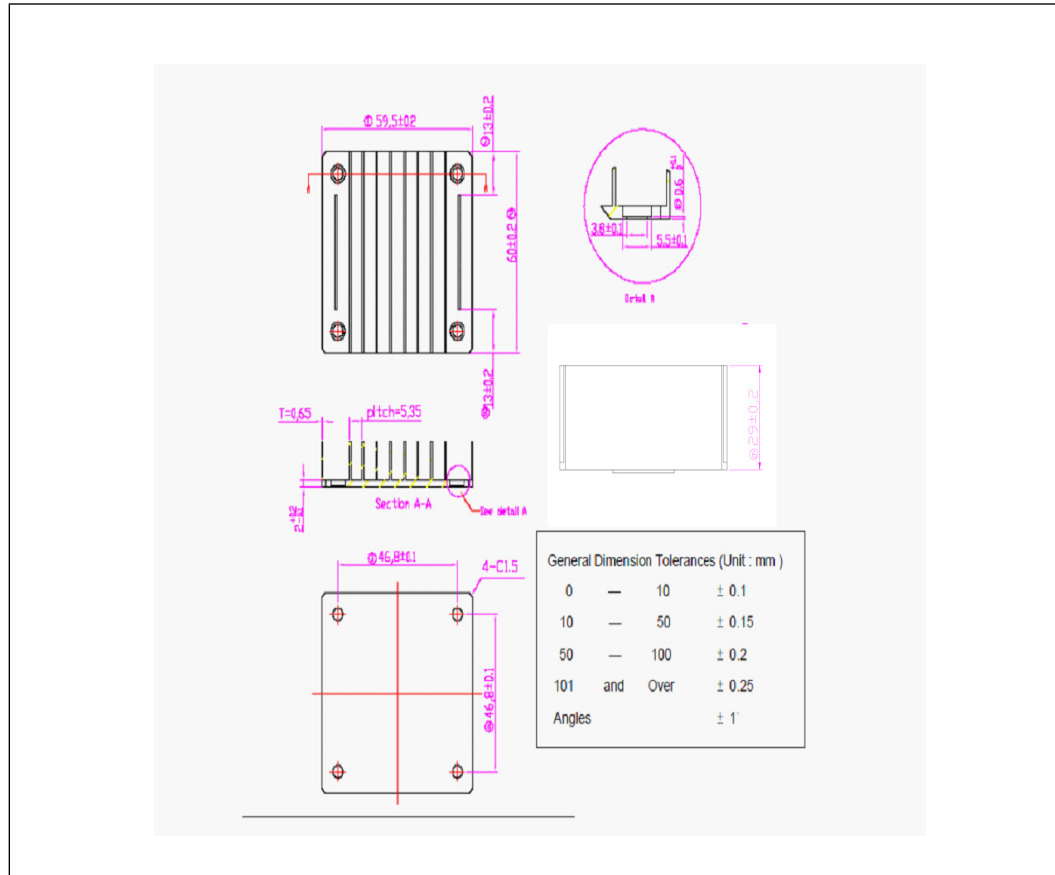
Figure 10. 1U Natural Convection Heatsink Mechanical Drawing

New Text:

Affected Docs:Figure 10 “1U Natural Convection Heatsink Mechanical Drawing” of Intel® Atom™ Processor E6xx Series Thermal and Mechanical Design Guidelines, Rev 003.
