Customer Process Change Notification Form

PCN-2013-497

CS5484-INZ(R)

Errata: CS5484 Rev B2 Silicon

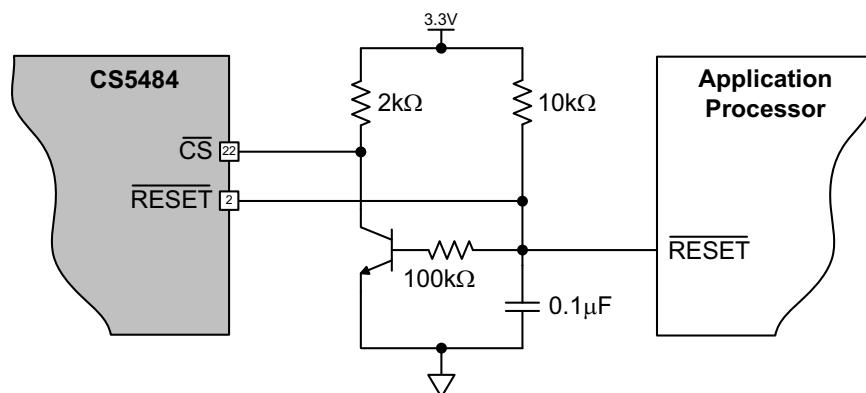
Figure 1. Chip Select Pin \overline{CS} Model

This erratum applies only to designs with chip select pin \overline{CS} tied low. If Serial Peripheral Interface (SPI) communication is interrupted, a synchronization error may occur on future SPI communications. A standard reset does not clear the SPI logic and correct this synchronization error.

Chip select pin \overline{CS} must be toggled to reset the SPI Interface. A NPN inverter may be added to the \overline{RESET} signal to obtain a suitable CS signal to reset the SPI Interface without the need for additional isolators. When the device is reset, using \overline{RESET} , the serial peripheral interface is also reset.
