Customer Process Change Notification Form

PCN-2013-501

CS5480-INZ(R)

Errata: CS5480 Rev B2 Silicon

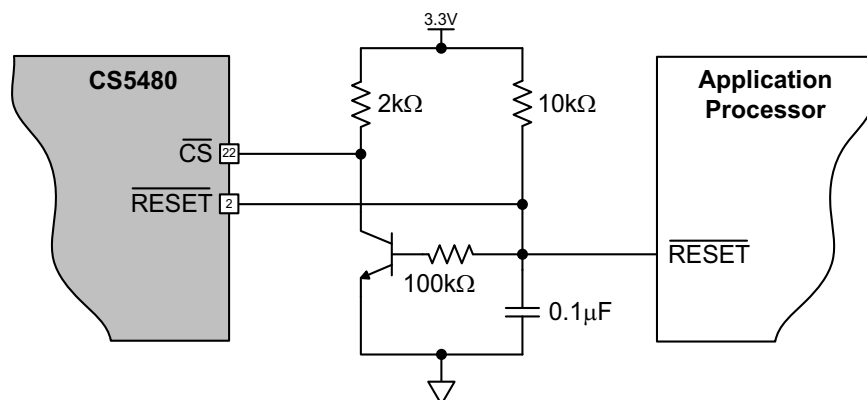
Figure 1. Chip Select Pin \overline{CS} Model

This erratum applies only to designs with chip select pin \overline{CS} tied low. If Serial Peripheral Interface (SPI) communication is interrupted, a synchronization error may occur on future SPI communications. A standard reset does not clear the SPI logic and correct this synchronization error.

Chip select pin \overline{CS} must be toggled to reset the SPI Interface. A NPN inverter may be added to the \overline{RESET} signal to obtain a suitable \overline{CS} signal to reset the SPI Interface without the need for additional isolators. When the device is reset, using \overline{RESET} , the serial peripheral interface is also reset.
