dsPIC33CK256MP508 Family Silicon Errata and Data Sheet Clarification

The dsPIC33CK256MP508 family devices that you have received conform functionally to the current Device Data Sheet (DS70005349K), except for the anomalies described in this document.

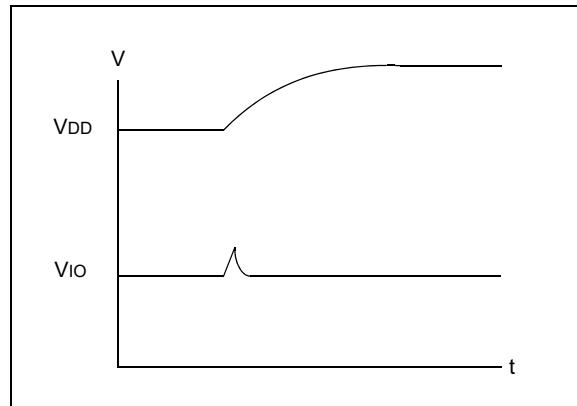
FIGURE 1-1: I/O RAMP

During a fast device power-up when the VDD ramp is less than 4 mS, the I/O pins may drive up to 100 μ A current for a duration of up to 10 μ S (Figure 1-1).

Example applications affected may include complementary power switches, where a transient current shoot-through might occur. High-voltage applications with complementary switches should power the high-voltage 200 μ Sec later than powering the dsPIC® device to avoid the current shoot-through. This behavior is specific to each device and not affected by aging.

1. Slow down the VDD ramp time (greater than 4 mS for VDD to ramp 0V to 3.3V).
2. Ensure the circuitry that is connected to the pins can endure this pulse.
