### PIC32MX1XX/2XX/5XX 64/100-pin Family Silicon Errata and Data Sheet Clarification

The PIC32MX1XX/2XX/5XX 64/100-pin family of devices that you have received conform functionally to the current Device Data Sheet (DS20006624AC), except for the anomalies described in this document.

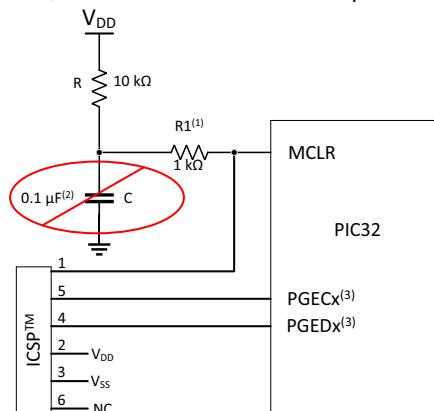
On power up, the internal Flash memory contents may be corrupted if MCLR is active before BOR event is reached. Either or both of the following workarounds may be required to prevent this issue.

If, not using an external reset supervisor IC or equivalent, remove the MCLR capacitor as shown below, and retain the MCLR Pull-up resistor.

If using an external reset supervisor IC or equivalent, increase the value of the VCAP capacitor to  $\geq 47 \mu\text{F}$  ceramic or solid tantalum capacitor with an ESR  $\leq 1 \Omega$ .
