dsPIC33EVXXXGM00X/10X Family Silicon Errata and Data Sheet Clarification

The dsPIC33EVXXXGM00X/10X family devices that you have received conform functionally to the current Device Data Sheet (DS70005144H), except for the anomalies described in this document.

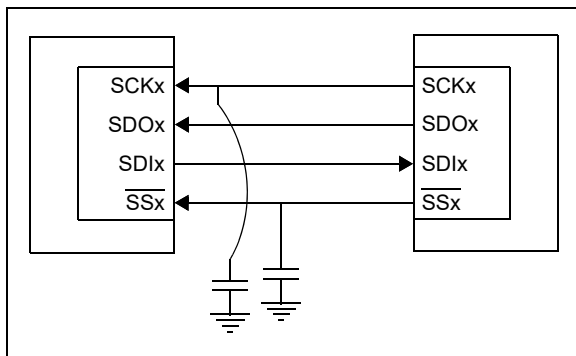
FIGURE 1:

When the SPIx module is configured in SPIx Client mode (MSTEN bit (SPIxCON1[5]) = 0), the frame client (FRMEN bit (SPIxCON2[15]) = 1) and the SPIFSD bit (SPIxCON2[14]) = 1, in Standard Buffer mode with the Clock Polarity Select bit, CKP = 0, the data are not transmitted in both 8-bit and 16-bit mode, but the data are being received correctly.

Adding a capacitance on the signal, as shown in Figure 1, will help the data to be received properly.

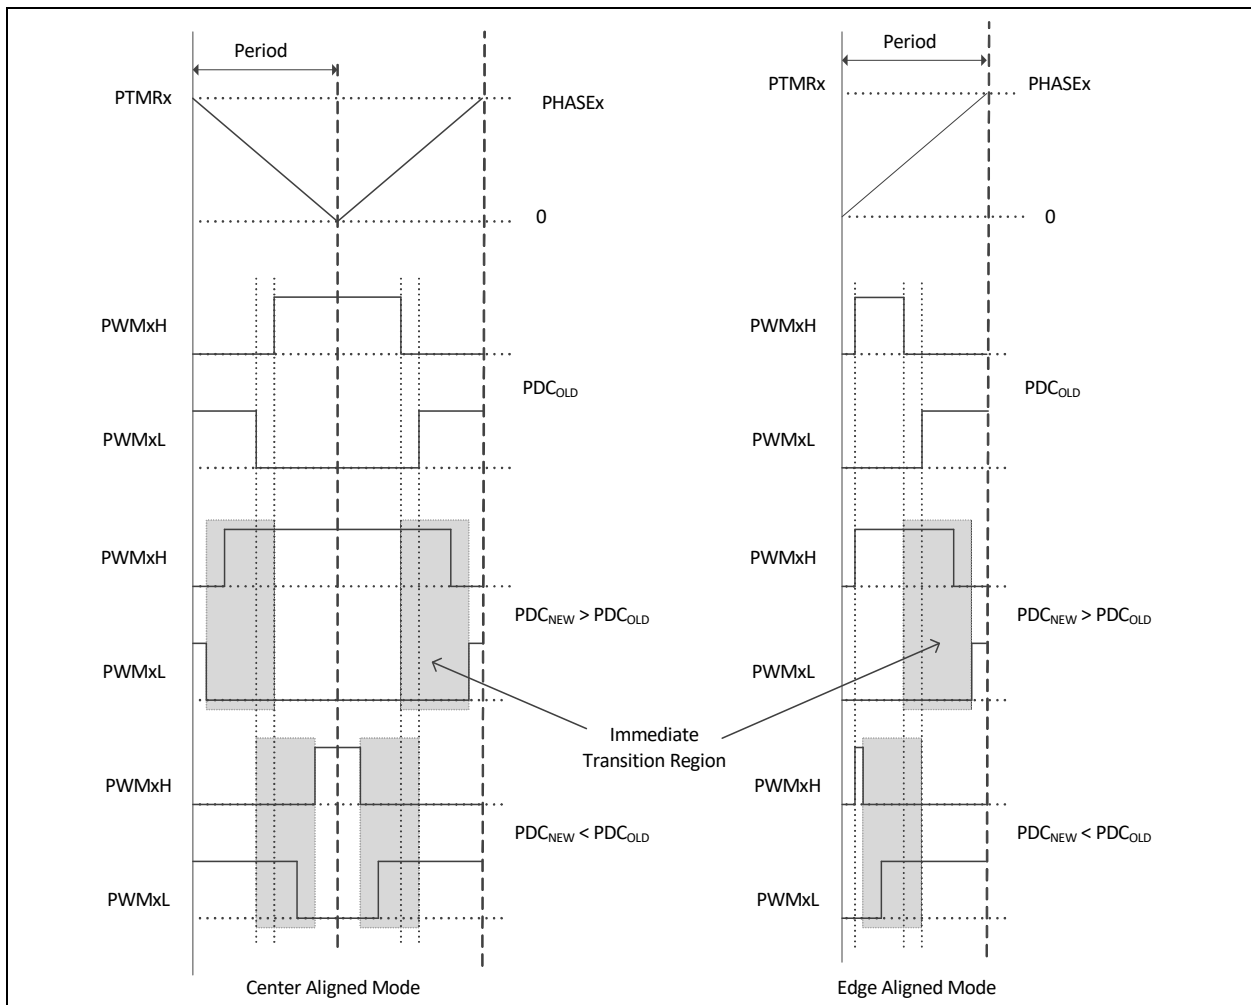
FIGURE 2: TIMING DIAGRAMS FOR CENTER-ALIGNED AND EDGE-ALIGNED MODES

The PWM generator may not assert dead time on the edges of transitions. This has been observed when all of the following conditions are present:

In [Figure 2](#), if the duty cycle write occurred in the shaded box, then PWMxH and PWMxL will make an immediate transition without dead time.

However, in most applications, the duty cycle update timing can be controlled using the TRIGx trigger or Special Event Trigger, such that the above mentioned conditions are avoided altogether.

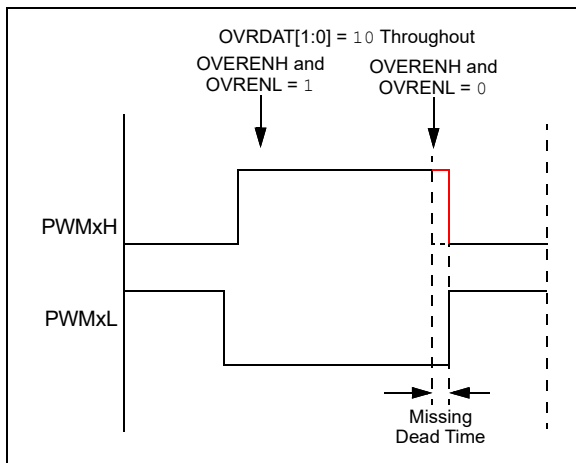
FIGURE 4:

- Output override synchronization is configured to occur on the CPU clock boundary (IOCONx[0] = 0);
- Both PWMxH and PWMxL overrides are enabled prior to the event (OVRENH and OVRENL are both '1'), and
- Both overrides are disabled (OVRENH and OVRENL are both '0') at the instant the dead time should be asserted (Figure 4). This has been observed in both Center-Aligned and Edge-Aligned modes.

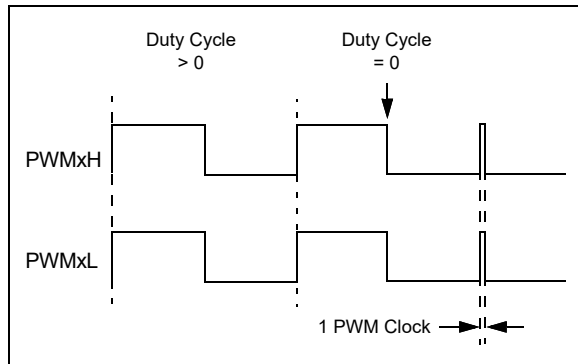
FIGURE 5:

In the Redundant Output mode (IOCONx[11:10] = 10) and Push-Pull Output mode (IOCONx[11:10] = 01) with Immediate Update disabled (PWMCONx[0] = 0), when the Duty Cycle register is updated from a non-zero value to zero, a glitch pulse of a width equal to one PWM clock will appear at the next PWM period boundary, as shown in Figure 5, for the Redundant Output mode. Here, the Duty Cycle register refers to the PDCx register if PWMCONx[8] = 0 or the MDC register if PWMCONx[8] = 1.

If the application requires a zero duty cycle output, there are two possible work around methods:

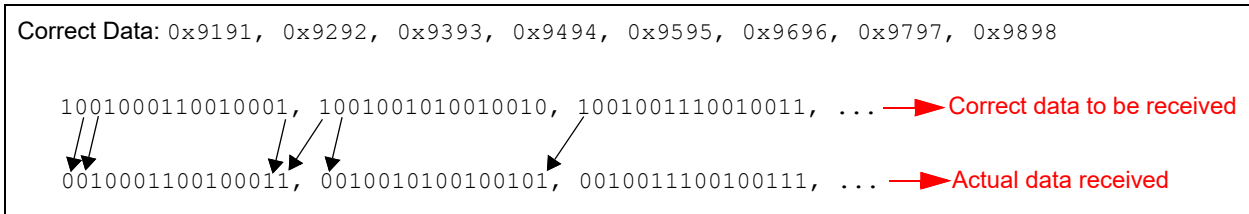
FIGURE 6:

Received data of the SPI are sampled one clock cycle late for the following conditions:

For example, the correct data that should be received are 0x9191, 0x9292, 0x9393, 0x9494, 0x9595, 0x9696, 0x9797, 0x9898, but the actual data received are 0x2323, 0x2525, 0x2727, 0x2929, 0x2B2B, 0x2D2D, 0x2F2F, 0x3130 (Figure 6).

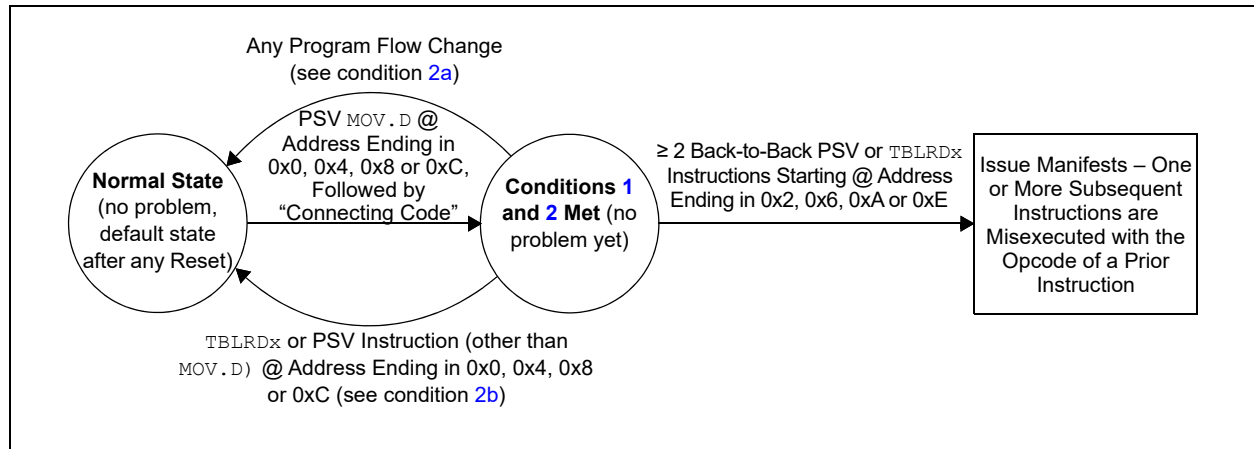
FIGURE 7: SIMPLIFIED BEHAVIOR

When two or more data Flash read instructions (via Program Space Visibility (PSV) read or table read) are executed back-to-back, one or more subsequent instructions can be misexecuted when all of the conditions in [Table 6](#) occur.

[Figure 7](#) provides an example of the effective behavior.

1. All instances of PSV MOV.D can be replaced with two PSV MOV instructions instead. Non-PSV MOV.D instructions acting on RAM/SFRs do not need to be modified; or
2. If not already present, a program flow change instruction (such as BRA \$+2) can be inserted above back-to-back data Flash read sequences; or
3. Back-to-back data Flash read instruction sequences can be broken up by inserting a non-Flash read instruction (such as a NOP), in between the Flash read instructions; or
4. The alignment of the code can be shifted to avoid the required opcode location addresses.
