dsPIC33CH512MP508 Family Silicon Errata and Data Sheet Clarification

The dsPIC33CH512MP508 family devices that you have received conform functionally to the current Device Data Sheet (DS70005371E), except for the anomalies described in this document.

Note: This document summarizes all silicon errata issues from all revisions of silicon, previous as well as current. Only the issues indicated in the last column of [Table 2](#) apply to the current silicon revision (**A3**).

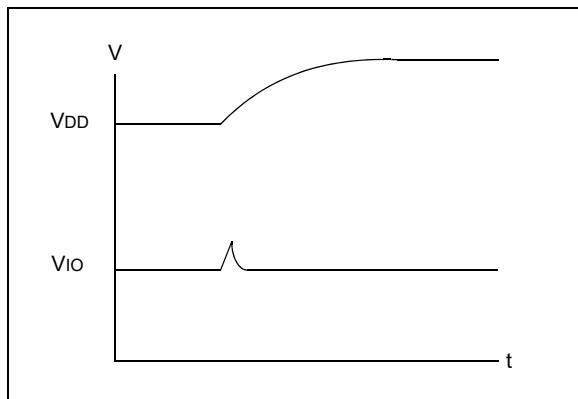
FIGURE 1-1: I/O RAMP

18. Module: I/O

During a fast device power-up, when the VDD ramp is less than 4 mS, the I/O pins may drive up to 100 μ A current for a duration of up to 10 μ S (Figure 1-1).

Example applications affected may include complementary power switches, where a transient current shoot-through might occur. High-voltage applications with complementary switches should power the high-voltage 200 μ Sec later than powering the dsPIC® device to avoid the current shoot-through. This behavior is specific to each device and not affected by aging.

1. Slow down the VDD ramp time (greater than 4 mS for VDD to ramp 0V to 3.3V).
2. Ensure the circuitry that is connected to the pins can endure this pulse.
