# PIC18F25/45/55Q43 Silicon Errata and Data Sheet

### PIC18F25/45/55Q43

The PIC18F25/45/55Q43 devices you have received conform functionally to the current device data sheet (DS40002170F), except for the anomalies described in this document.

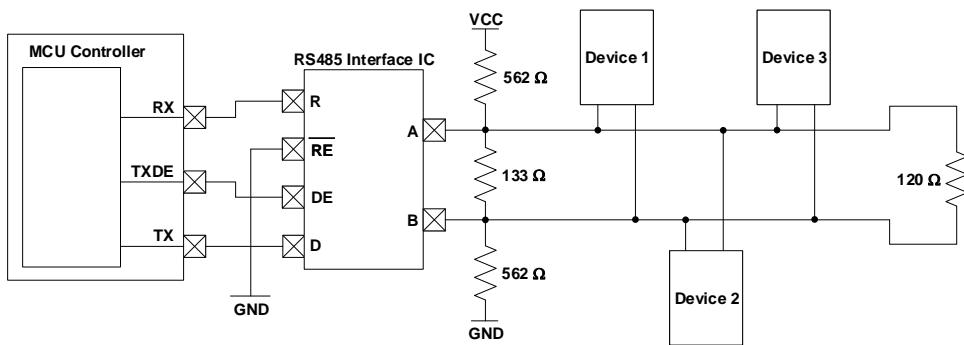
### 1.7.1 UART TXDE Signal May Go Low Before the STOP Bit Has Been Entirely Transmitted

The UART Transmit Drive Enable (TXDE) signal could potentially transition into a low state before the UART STOP bit has been entirely transmitted due to the effects of parasitic capacitance on the TX line. In some applications, this could result in communication being prematurely terminated due to the TXDE bit going low before the STOP bit has had enough time to settle.

To ensure that the STOP bit settles into its final logic state before the TXDE signal transitions low, a biasing circuit can be implemented. A biasing circuit allows the TX line to either be driven high or low, rather than being left in a floating tri-state mode where prolonged rise or fall times could lead to communication being disrupted. This bias circuit should only be implemented on one end of the serial bus, and a termination resistor should be used on the other end. The figure below shows an example of a bias circuit that can be used to achieve this.

Please note that the resistor values used in this circuit are recommendations, and that the actual resistor values required may vary based on the application.
