Silicon Errata and Data Sheet Clarifications

ATtiny3216/3217

Introduction

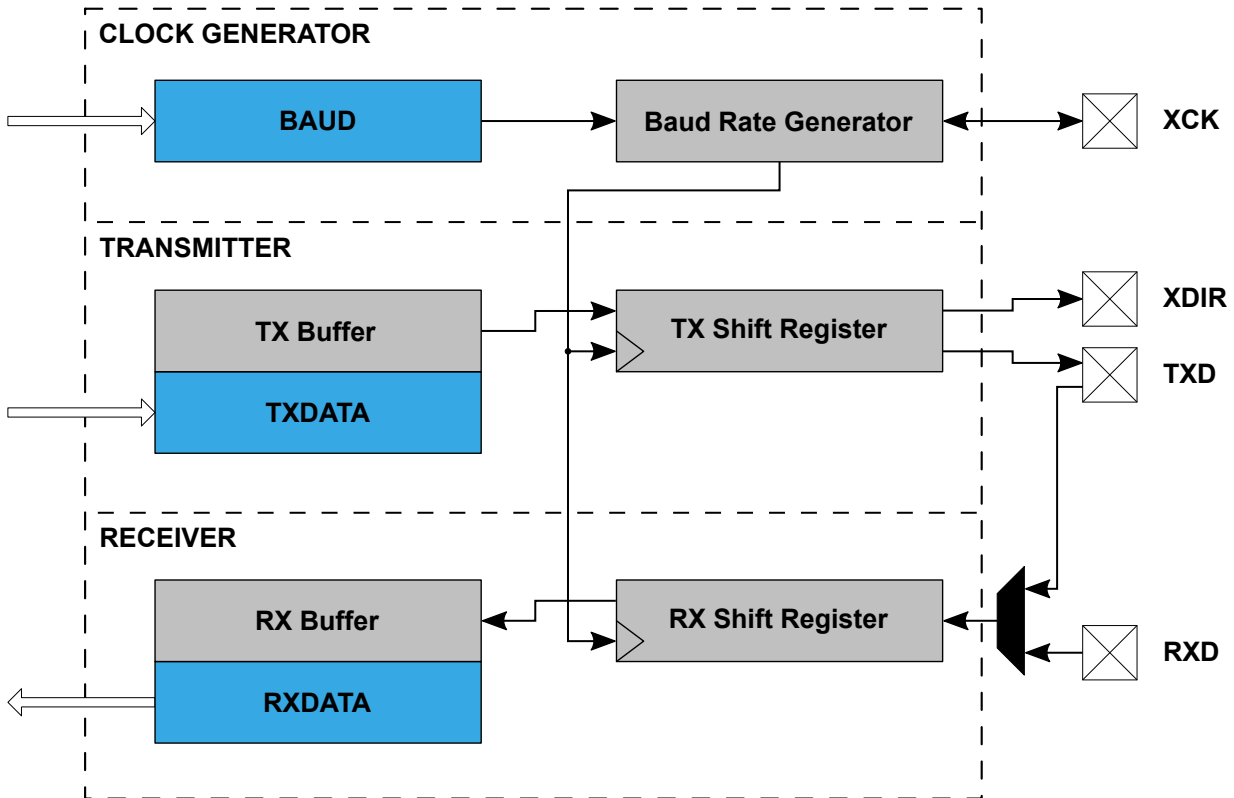
Figure 24-1. USART Block Diagram

The block diagram is missing that USART TX is double-buffered from *Figure 24-1. USART Block Diagram* in the data sheet. The figure below shows the added **TX Buffer**.

The transmitter consists of a **two-level** write buffer.

The data transmission is initiated by loading the **Transmit Data (USARTn.TXDATAL and USARTn.TXDATAH) registers** with the data to be sent. The data in the **Transmit Data registers are moved to the TX Buffer** once emptied and then to the Shift register once it is empty and ready to send a new frame.
