Introduction

The PIC18F06/16Q40 devices you have received conform functionally to the current device data sheet (DS40002216F), except for the anomalies described in this document.

Table 1. Silicon Device Identification

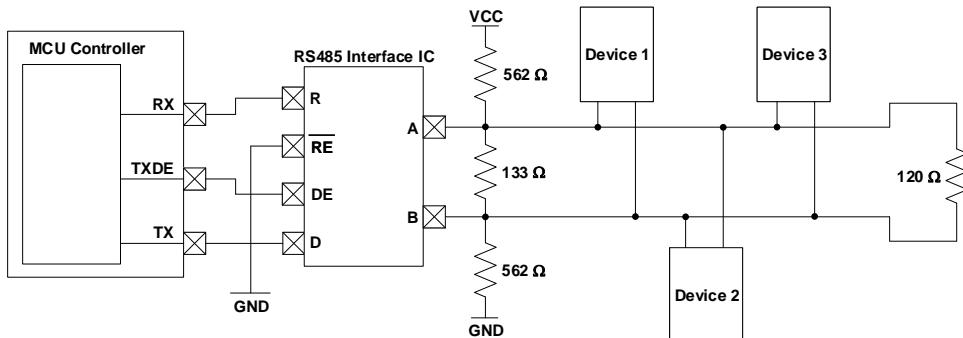
1.4.1 UART TXDE Signal May Go Low Before the STOP Bit Has Been Entirely Transmitted

The UART Transmit Drive Enable (TXDE) signal could potentially transition into a low state before the UART STOP bit has been entirely transmitted due to the effects of parasitic capacitance on the TX line. In some applications, this could result in communication being prematurely terminated due to the TXDE signal going low before the STOP bit has had enough time to settle.

To ensure that the STOP bit settles into its final logic state before the TXDE signal transitions low, a biasing circuit can be implemented. A biasing circuit allows the TX line to either be driven high or low, rather than being left in a floating tri-state mode where prolonged rise or fall times could lead

to communication being disrupted. This bias circuit should only be implemented on one end of the serial bus, and a termination resistor should be used on the other end. The figure below shows an example of a bias circuit that can be used to achieve this.

Please note that the resistor values used in this circuit are recommendations and that the actual resistor values required may vary based on the application.
