# PIC18F06/16Q41 Silicon Errata and Data Sheet

### PIC18F06/16Q41

The PIC18F06/16Q41 devices you have received conform functionally to the current device data sheet (DS40002214E), except for the anomalies described in this document.

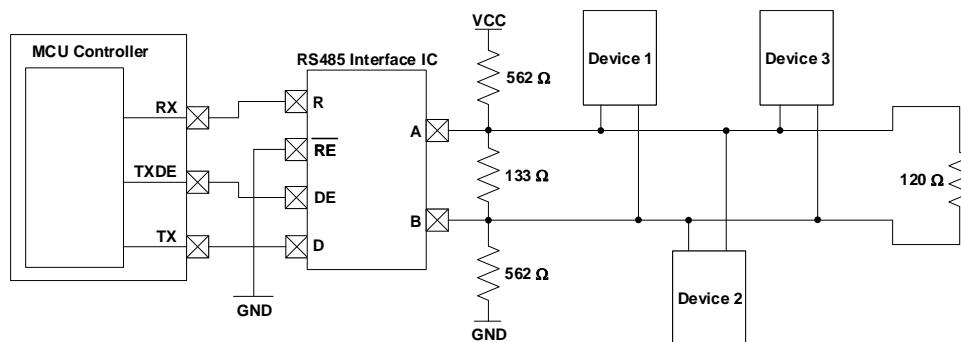
#### 1.5.1 UART TXDE Signal May Go Low Before the STOP Bit Has Been Entirely Transmitted

The UART Transmit Drive Enable (TXDE) signal could potentially transition into a low state before the UART STOP bit has been entirely transmitted due to the effects of parasitic capacitance on the TX line. In some applications, this could result in communication being prematurely terminated due to the TXDE bit going low before the STOP bit has had enough time to settle.

To ensure that the STOP bit settles into its final logic state before the TXDE signal transitions low, a biasing circuit can be implemented. A biasing circuit allows the TX line to either be driven high or low, rather than being left in a floating tri-state mode where prolonged rise or fall times could lead to communication being disrupted. This bias circuit should only be implemented on one end of the serial bus, and a termination resistor should be used on the other end. The figure below shows an example of a bias circuit that can be used to achieve this.

Please note that the resistor values used in this circuit are recommendations, and that the actual resistor values required may vary based on the application.
