dsPIC33EDV64MC205 Silicon Errata and Data Sheet Clarification

The dsPIC33EDV64MC205 device that you have received conforms functionally to the current Device Data Sheet (DS70005292F), except for the anomalies described in this document.

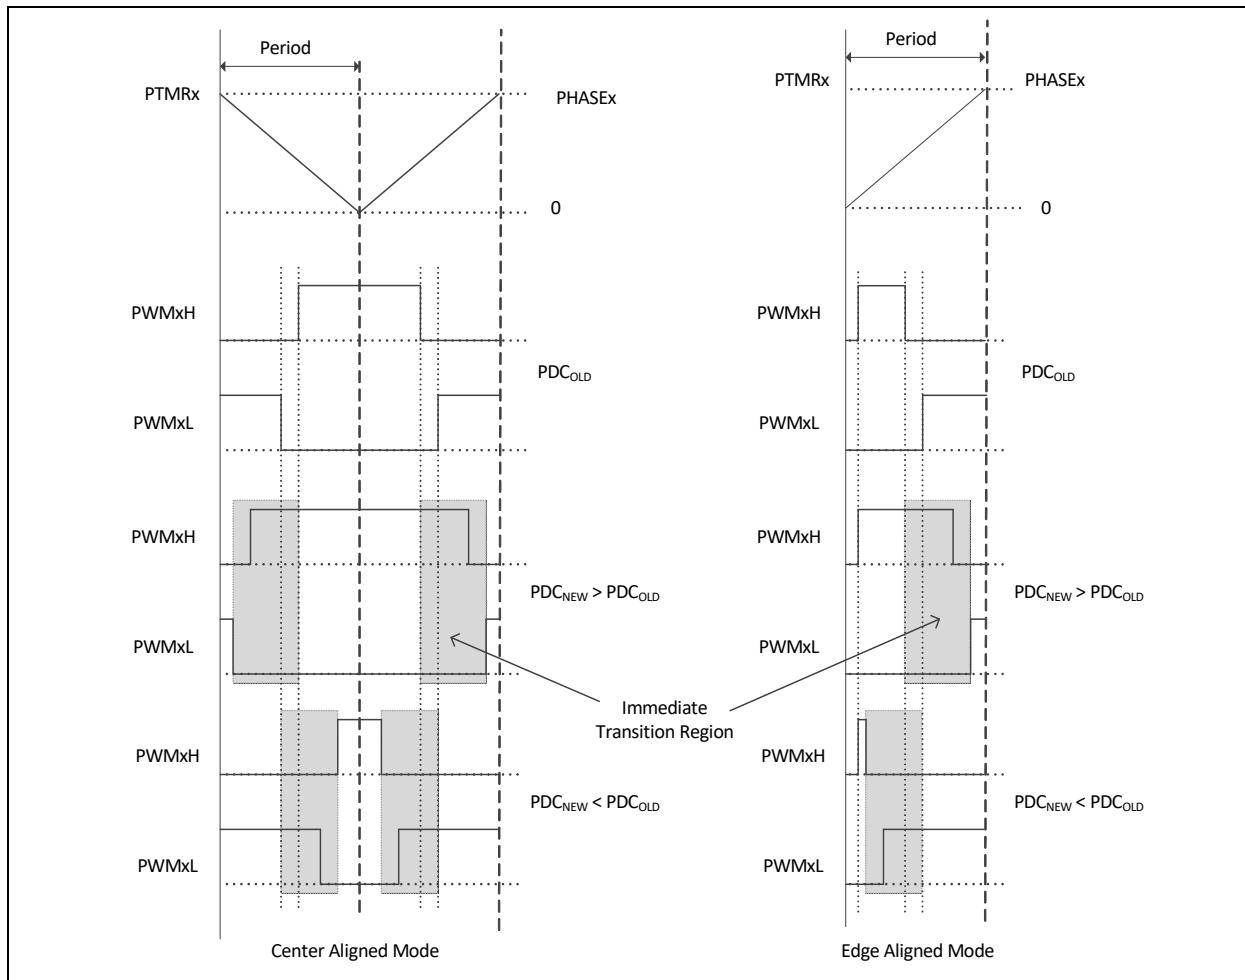
FIGURE 1: TIMING DIAGRAMS FOR CENTER-ALIGNED AND EDGE-ALIGNED MODES

The PWM generator may not assert dead time on the edges of transitions. This has been observed when all of the following conditions are present:

- The PWM generator is configured to operate in Complementary mode with Independent Time Base (ITB) or master time base;
- Immediate update is enabled; and
- The value in the PDCx register is updated in such a manner that the PWMxH and PWMxL outputs make an immediate transition.

The current duty cycle, PDCOLD, newly calculated duty cycle, PDCNEW, and the point at which a write to the Duty Cycle register occurs within the PWM

time base, will determine if the PWMxH and PWMxL outputs make an immediate transition. PWMxH and PWMxL outputs make an immediate transition if the Duty Cycle register is written with a new value, PDCNEW, at a point of time when the PWM time base is counting a value that is in between PDCNEW and PDCOLD. Additionally, writing to the Duty Cycle register, close to the instant of time where dead time is being applied, may result in a reduced dead time effective on the PWMxH and PWMxL transition edges.

In [Figure 1](#), if the duty cycle write occurred in the shaded box, then PWMxH and PWMxL will make an immediate transition without dead time.

However, in most applications the duty cycle update timing can be controlled using the TRIGx trigger, or Special Event Trigger, such that the above mentioned conditions are avoided altogether.

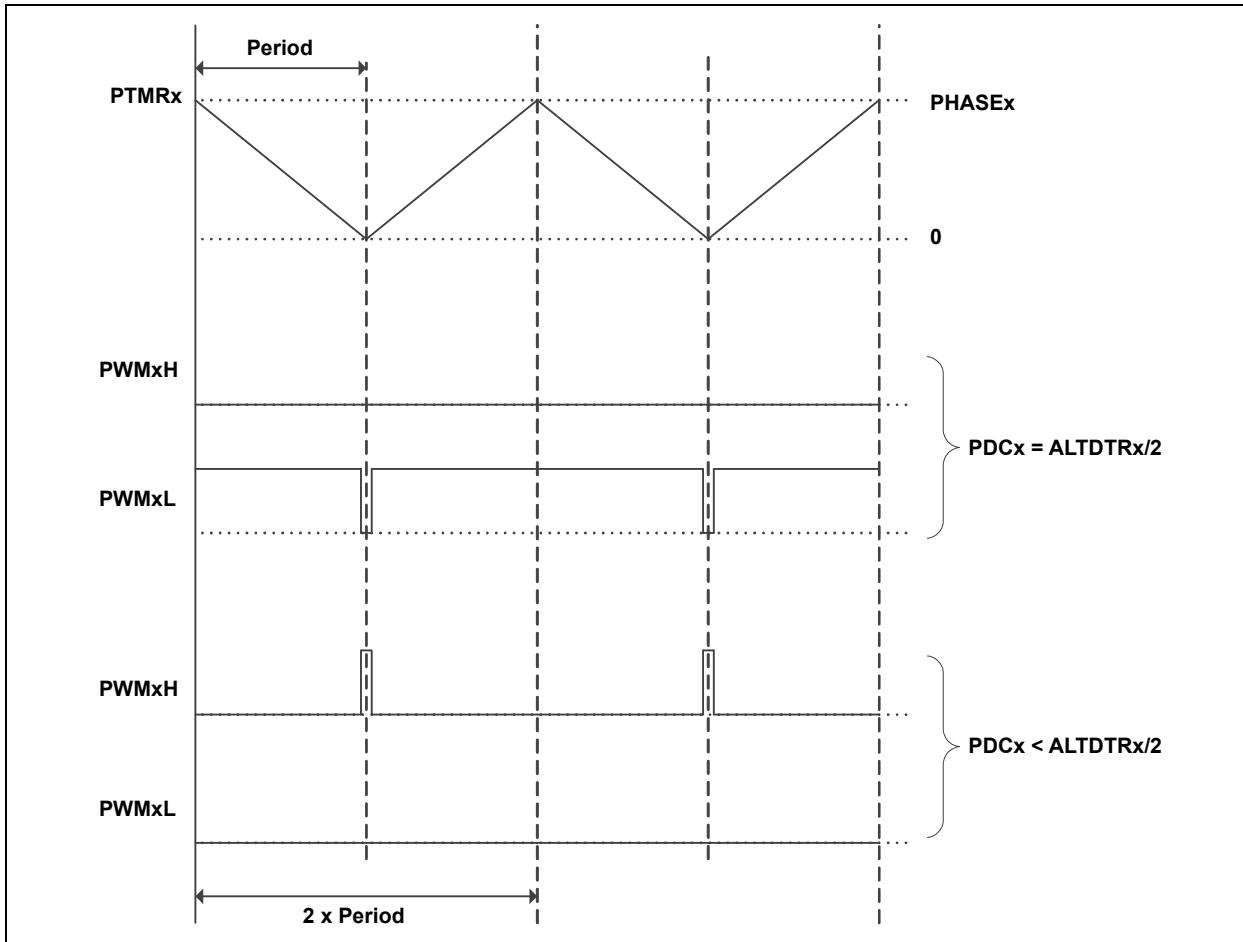
FIGURE 2: PWM GENERATOR TIMING DIAGRAM

In Center-Aligned Complementary mode with Independent Time Base, if the value in the PDCx register is less than one-half the value in the ALTDTRx register, the PWM generator will force the PWMxL to low, and on the PWMxH, generate pulses of width less than twice the dead time, as shown in [Figure 2](#).

Include a software routine to ensure that the duty cycle value written to the PDCx register is always at least one-half of the value in ALTDTRx. [Example 2](#) shows one method, with **PDCtemp** representing the variable which has the value to be written to the PDCx register. Alternatively, for duty cycle values less than half the desired dead-time value, zero out the ALTDTRx register or dynamically reduce the value in the ALTDTRx register, such that ALTDTRx is always equal to 2 * PDCx, as shown in [Example 3](#).

```
Altdtr_by2 = ALTDTRx / 2;
if (PDCtemp < Altdtr_by2)
{
    PDCx = Altdtr_by2;
}
else
{
    PDCx = PDCtemp;
}
```

```
#define DESIRED_DEADTIME 100
if (PDCtemp < (DESIRED_DEADTIME/2))
{
    ALTDTRx = PDCtemp * 2;
    PDCx = PDCtemp;
}
else
{
    ALTDTRx = DESIRED_DEADTIME;
    PDCx = PDCtemp;
}
```

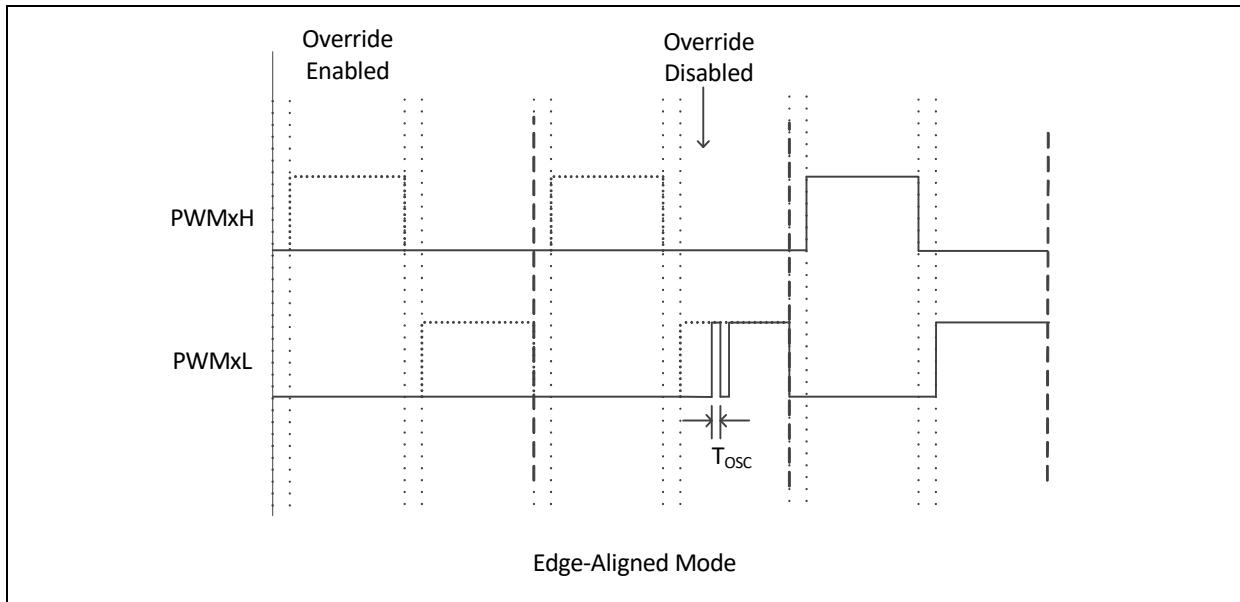
FIGURE 3: ILLUSTRATION OF 1 Tosc GLITCH WHEN PWM OVERRIDE IS TURNED OFF

In Complementary mode after the PWM_x module is enabled (PTEN = 1), if the PWM override is turned off, a 1 Tosc glitch will be present on the rising edge of either PWM_{xH} or PWM_{xL}, whichever occurs first, as shown in [Figure 3](#). The glitch will be present on PWM_{xH}/PWM_{xL} every time the override state is changed from enabled to disabled. The width of this glitch is equal to 1 Tosc when PCLKDIV[2:0] = 000; increasing the PWM input clock prescaler setting will increase the width of the glitch accordingly.

Since the width of the glitch is just 1 Tosc at higher values of Fosc, the glitch may not be visible on the PWM_{xH}/PWM_{xL} pins due to pin and PCB trace capacitances.

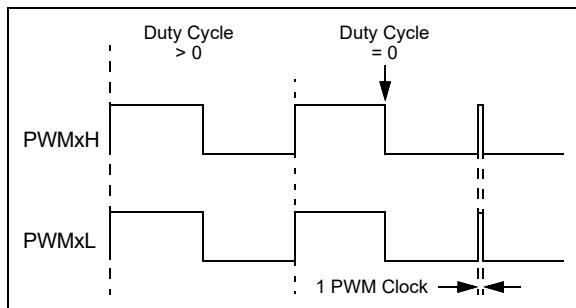
FIGURE 4:

In certain output modes, the PWM_x module produces a pulse glitch of one PWM clock in width (Figure 4). This has been observed only when all of the following are true:

- Either Redundant or Push-Pull Output mode is selected (IOCON_x[11:10] = 10 or 01);
- Immediate Update is disabled (PWMCON_x[0] = 0); and
- The value of the current Duty Cycle register (either the PDC_x or MDC register, as determined by PWMCON_x[8]) is updated to zero from any non-zero value.

The pulse glitch has been observed to occur at the beginning of the following PWM boundary period.

If the application requires a duty cycle of zero, two possible work arounds are available.

1. Use the PWM overrides to force the output to a low state instead of writing a '0' to the Duty Cycle register. When using this method, the PWM override must be disabled when the duty cycle is a non-zero value. If output override synchronization is configured to occur on CPU clock boundaries (IOCON_x[0] = 0), enabling and disabling the override must be timed to occur as closely as possible to the PWM period boundary.
2. Configure the module for Immediate Update (PWMCON_x[0] = 1) before enabling the module. In this mode, writes to the Duty Cycle register have an immediate effect on the output. As with the previous work around, writes to the Duty Cycle register must be timed to occur as close to the PWM period boundary as possible in order to avoid distortion of the output.

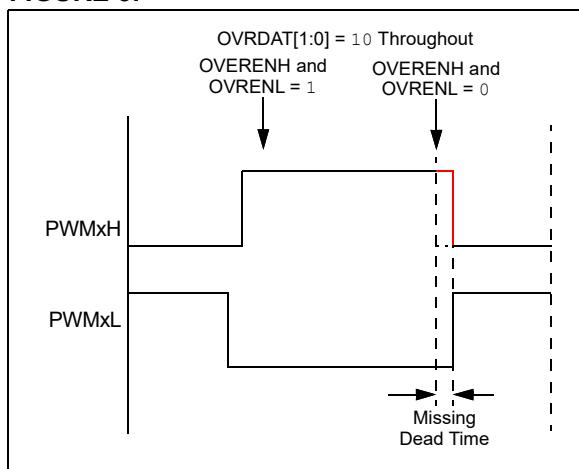
FIGURE 5:

In Complementary Output mode, the expected dead time between transitions of the PWMxH and PWMxL outputs may not be asserted when the following occurs:

- Output override synchronization is configured to occur on the CPU clock boundary (IOCONx[0] = 0);
- Both PWMxH and PWMxL overrides are enabled prior to the event (OVRENH and OVRENL are both '1'), and
- Both overrides are disabled (OVRENH and OVRENL are both '0') at the instant the dead time should be asserted ([Figure 5](#)).

This has been observed in both Center-Aligned and Edge-Aligned modes.

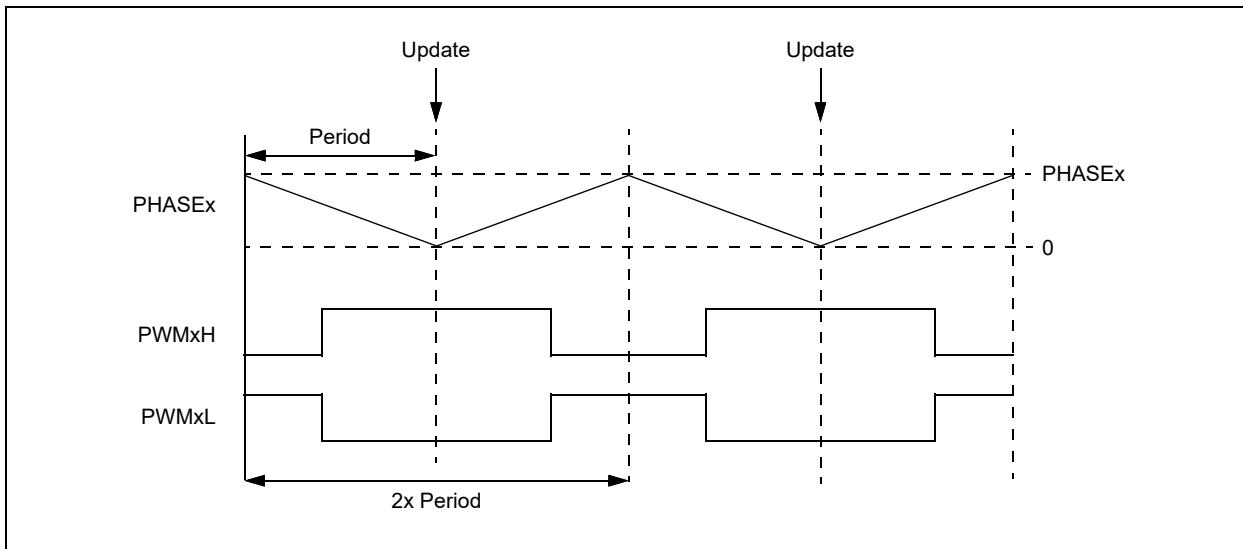
FIGURE 6:

In Center-Aligned Complementary mode with Independent Time Base, updates to the PHASE_x register take effect in the middle of a center-aligned PWM cycle, as shown in [Figure 6](#). This occurs only when the Immediate Update feature is disabled (IUE = 0). If Immediate Update is enabled (IUE = 1), the PHASE_x register updates will take effect immediately.
