PIC18F27/47/57Q83 Silicon Errata and Data Sheet

Clarifications

PIC18F27/47/57Q83

The PIC18F27/47/57Q83 devices that you have received conform functionally to the current device data sheet (DS40002265C), except for the anomalies described in this document.

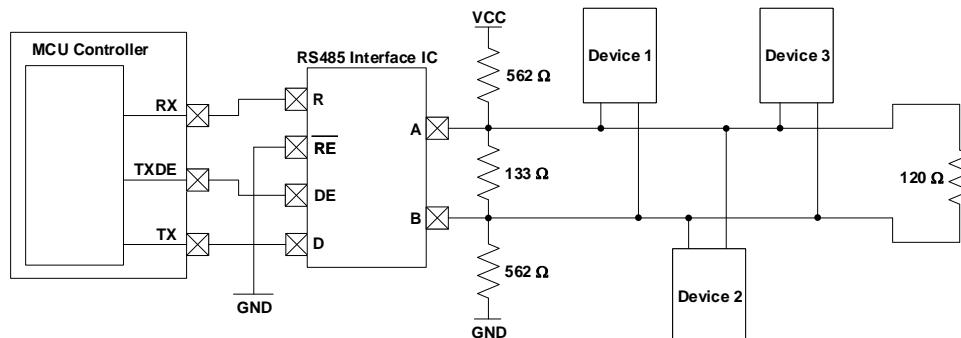
1.6.1 UART TXDE Signal May Go Low before the STOP Bit Has Been Entirely Transmitted

The UART Transmit Drive Enable (TXDE) signal could potentially transition into a low state before the UART STOP bit has been entirely transmitted due to the effects of parasitic capacitance on the TX line. In some applications, this could result in communication being prematurely terminated due to the TXDE bit going low before the STOP bit has had enough time to settle.

To ensure that the STOP bit settles into its final logic state before the TXDE signal transitions low, a biasing circuit can be implemented. A biasing circuit allows the TX line to either be driven high or low, rather than being left in a floating tri-state mode where prolonged rise or fall times could lead to communication being disrupted. This bias circuit should only be implemented on one end of the serial bus, and a termination resistor should be used on the other end. The figure below shows an example of a bias circuit that can be used to achieve this.

Please note that the resistor values used in this circuit are recommendations and that the actual resistor values required may vary based on the application.
