Introduction

The PIC18F04/05/14/15Q40 devices you have received conform functionally to the current device data sheet (DS40002236E), except for the anomalies described in this document.

The silicon issues discussed in the following pages are for silicon revisions with the Device and Revision IDs listed in the table below.

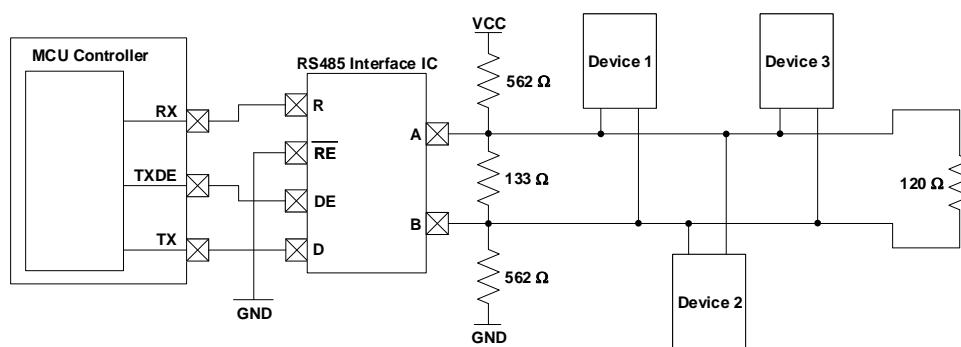
1.4.1 UART TXDE Signal May Go Low Before the STOP Bit Has Been Entirely Transmitted

The UART Transmit Drive Enable (TXDE) signal could potentially transition into a low state before the UART STOP bit has been entirely transmitted due to the effects of parasitic capacitance on the TX line. In some applications, this could result in communication being prematurely terminated due to the TXDE signal going low before the STOP bit has had enough time to settle.

To ensure that the STOP bit settles into its final logic state before the TXDE signal transitions low, a biasing circuit can be implemented. A biasing circuit allows the TX line to either be driven high or low, rather than being left in a floating tri-state mode where prolonged rise or fall times could lead to communication being disrupted. This bias circuit should only be implemented on one end of the serial bus, and a termination resistor should be used on the other end. The figure below shows an example of a bias circuit that can be used to achieve this.

Please note that the resistor values used in this circuit are recommendations and that the actual resistor values required may vary based on the application.
