PIC18F26/46/56Q83 Silicon Errata and Data Sheet

PIC18F26/46/56Q83

The PIC18F26/46/56Q83 devices that you have received conform functionally to the current device data sheet (DS40002253D), except for the anomalies described in this document.

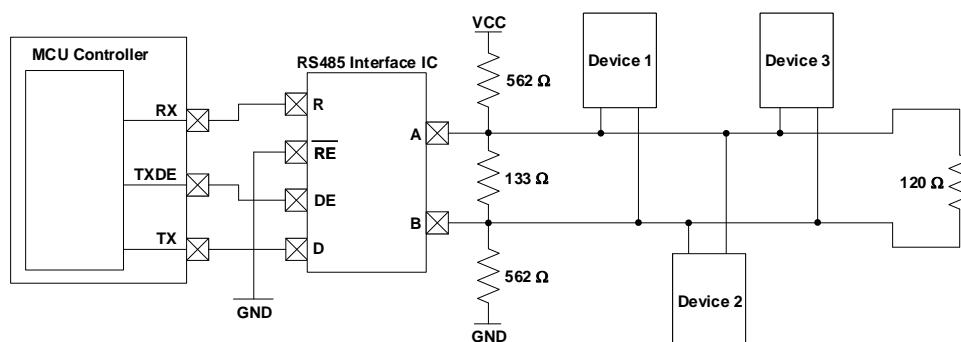
The UART Transmit Drive Enable (TXDE) signal could potentially transition into a low state before the UART STOP bit has been entirely transmitted due to the effects of parasitic capacitance on the TX line. In some applications, this could result in communication being prematurely terminated due to the TXDE bit going low before the STOP bit has had enough time to settle.

To ensure that the STOP bit settles into its final logic state before the TXDE signal transitions low, a biasing circuit can be implemented. A biasing circuit allows the TX line to either be driven high or low, rather than being left in a floating tri-state mode where prolonged rise or fall times could lead to communication being disrupted. This bias circuit should only be implemented on one end of the serial bus, and a termination resistor should be used on the other end. The figure below shows an example of a bias circuit that can be used to achieve this.

Please note that the resistor values used in this circuit are recommendations and that the actual resistor values required may vary based on the application.
