# TLE826xE/-2E

Universal System Basis Chip Family

## Errata Sheet

Rev. 1.00, 2012-02-28

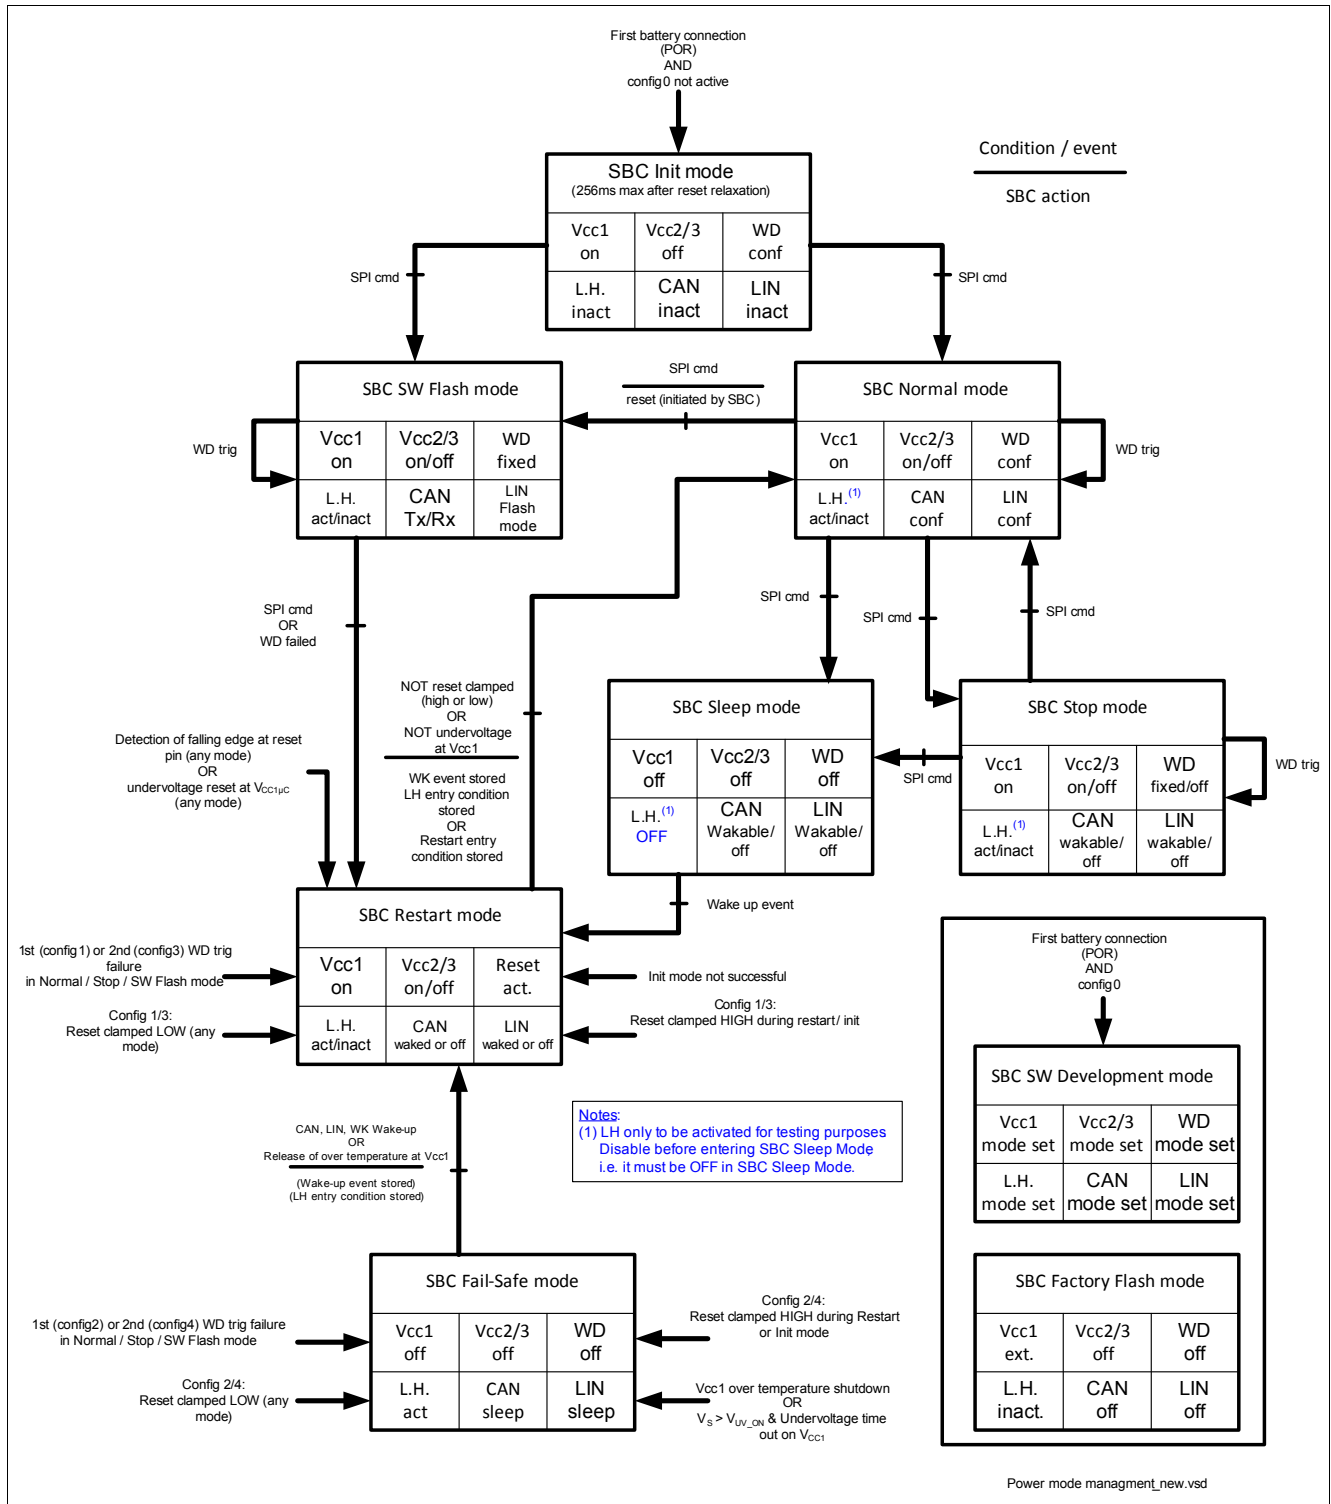
**Figure 1 LH Activation during SBC Sleep Mode Not Permitted**

Only occurs when Limp Home is active before entering SBC Sleep Mode

Approximately 4 min after entering SBC Sleep Mode

- $V_{cc1\_uC}$  undervoltage (UV) comparator can generate the chip-internal signal “no Vcc1\_UV” during SBC Sleep Mode after ~4 min
- Digital logic interprets  $V_{cc1\_uC}$  is enabled and reset output RO is internally set to “HIGH” after reset delay time (only occurs when Limp Home is activated)
- RO driver is not supplied ( $V_{cc1\_uC}$  is off in SBC Sleep Mode) → “Reset clamped low” (LH[2:0] = 110<sub>B</sub>) detected

- SBC detects failure and changes to SBC Restart Mode and switches on  $V_{cc1\_uC}$ , leading to SBC Normal Mode
- LH[2:0] shows 110<sub>B</sub> (“Reset clamped”) instead of 000<sub>B</sub>  
MS[2:0] shows 001<sub>B</sub> (coming from SBC Restart Mode) instead of 100<sub>B</sub> (coming from SBC Sleep Mode)  
RM[1:0] shows 01<sub>B</sub> (“Undervoltage on  $V_{cc1\_uC}$ ”) instead of 00<sub>B</sub>

- Unexpected device wake-up from SBC Sleep Mode after ~4 min without a wake source (CAN, LIN, WK) being set
- The same set of SPI responses could only be reached when a  $V_{cc1\_uC}$  undervoltage occurs in SBC Normal or Stop Mode and a “reset clamped” appears during the following SBC Restart Mode

- Do not activate LH before entering the SBC Sleep Mode (see also [Figure 1](#))
- Ensure that LH is disabled before entering SBC Sleep Mode, e.g. after a failure:
  - Check if the LH bit (bit 12 in the SBC Configuration Register CS[2:0] = 100<sub>B</sub>) is set
  - If the LH bit is set, then send a valid watchdog trigger. Otherwise the SBC can be sent to Sleep Mode immediately.
  - Disable the LH bit (*Note: this must be a separate SPI command*)

*Note: LH will be activated automatically due to a failure during the device operation and is not automatically disabled when entering SBC Normal Mode. Therefore, it must be ensured that LH is disabled before entering SBC Sleep Mode.*

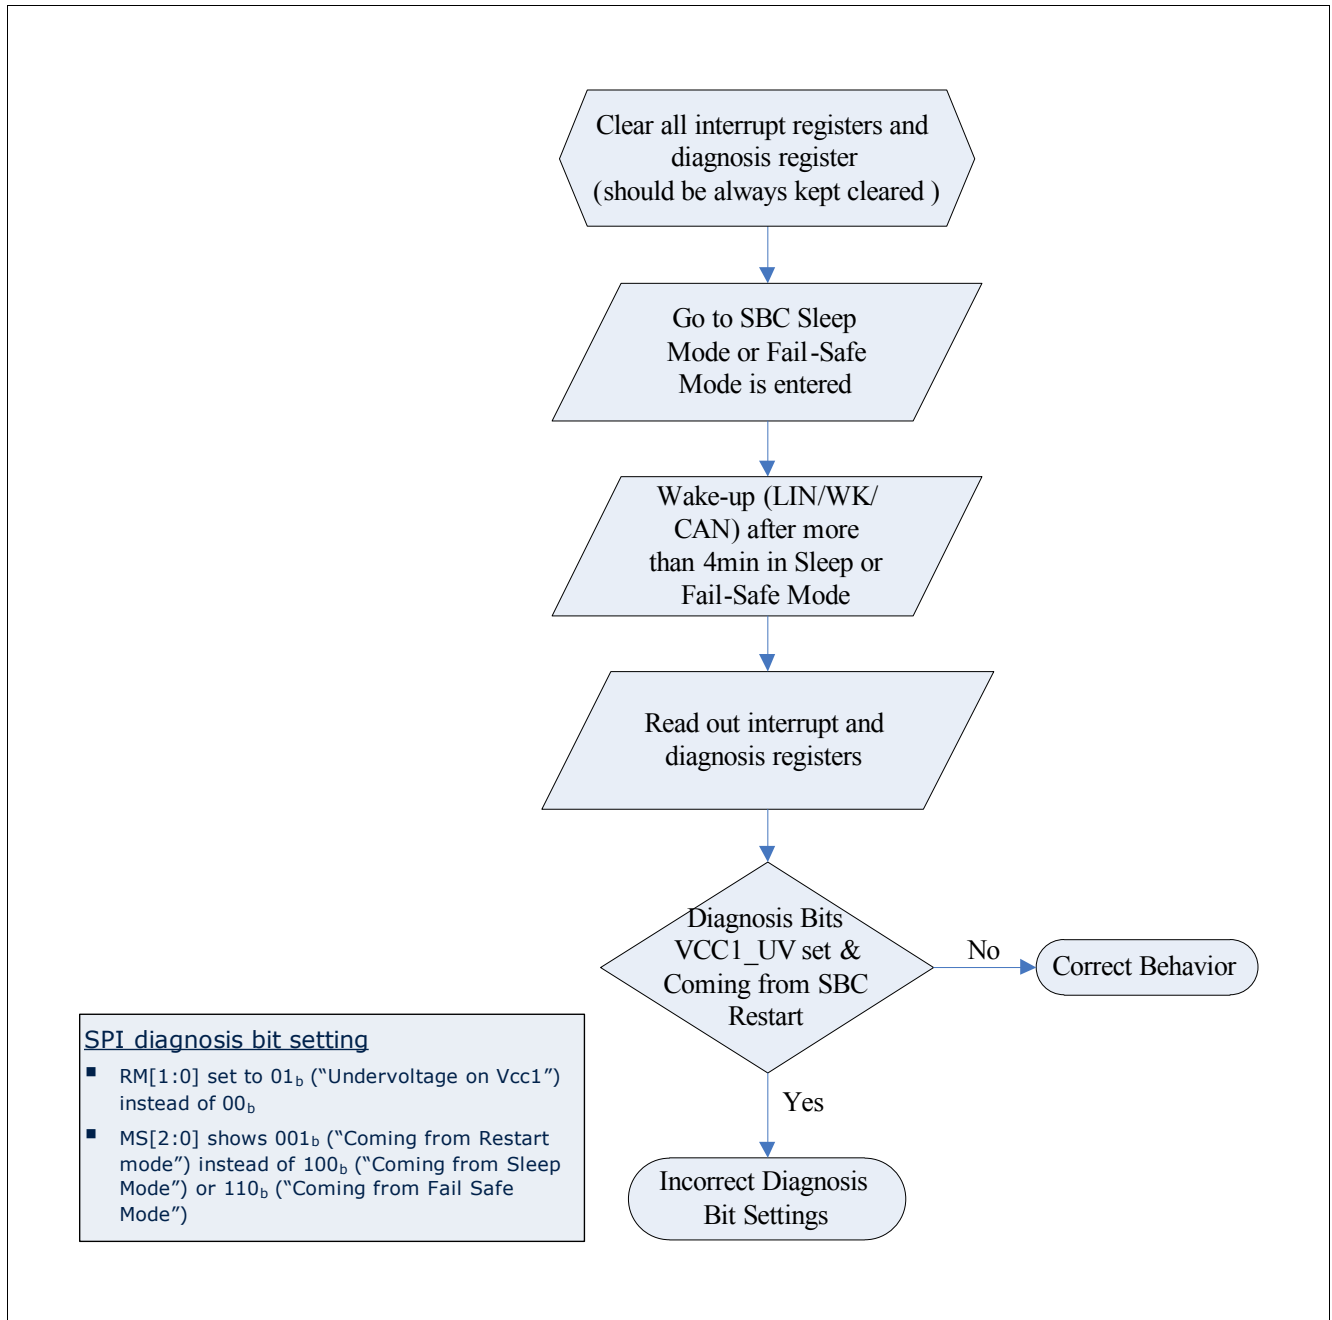
**Figure 2** Verifying actual device status after coming from SBC Sleep or Fail-Safe Mode

After a wake up (via CAN, LIN, WK) when the device was in SBC Sleep or Fail-Safe Mode for more than ~4 min

- $V_{cc1\_uC}$  undervoltage (UV) comparator generates the chip-internal signal "no Vcc1\_UV" during SBC Sleep or Fail-Safe Mode (see also [Chapter 2.1](#)) but device will only wake up by an external wake-up event on CAN, LIN or WK as defined in the datasheet.
- At the SBC mode transition from SBC Sleep or Fail-Safe Mode to Restart Mode  $V_{cc1\_uC}$  is enabled and  $V_{cc1\_uC}$  UV comparator shows correct signal "Vcc1\_UV". This transition from "no Vcc1\_UV" to "Vcc1\_UV" causes an unexpected failure signaling and the SPI bits RM[1:0] set to 01<sub>B</sub>.

- RM[1:0] set to 01<sub>B</sub> ("Undervoltage on  $V_{cc1\_uC}$ ") instead of 00<sub>B</sub>
- MS[2:0] shows 001<sub>B</sub> ("Coming from Restart Mode") instead of 100<sub>B</sub> ("Coming from Sleep Mode") or 110<sub>B</sub> ("Coming from Fail-Safe Mode") respectively

The same set of SPI responses can only be reached when  $V_{cc1\_uC}$  undervoltage occurs in SBC Normal or SBC Stop Mode and the Wake register wasn't cleared before.

- Always clear interrupt and diagnosis (Limp Home) registers before entering SBC Sleep Mode
- Save last SBC State in microcontroller, e.g. SBC was sent to SBC Sleep Mode
- Read out interrupt and diagnosis (Limp Home) registers after wake-up (see [Figure 2](#))

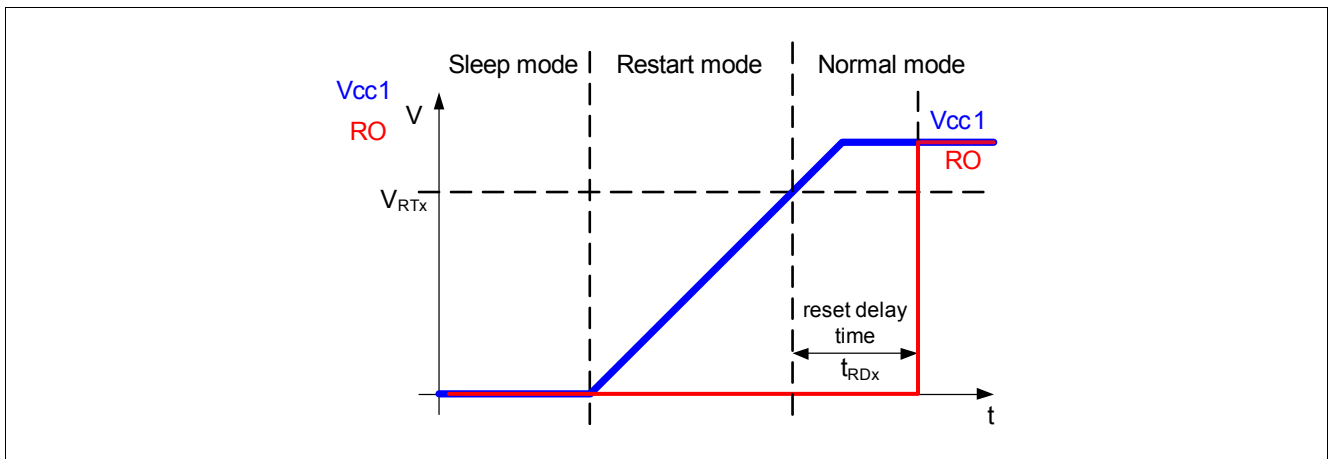
**Figure 3** Expected behavior of RO output with reset delay time

- The expected behavior of the reset output RO is shown in [Figure 3](#). When  $V_{cc1\_μC}$  reaches the selected  $V_{RTx}$  threshold the selected reset delay time ( $t_{RDx}$ ) is started. RO is released after  $t_{RDx}$

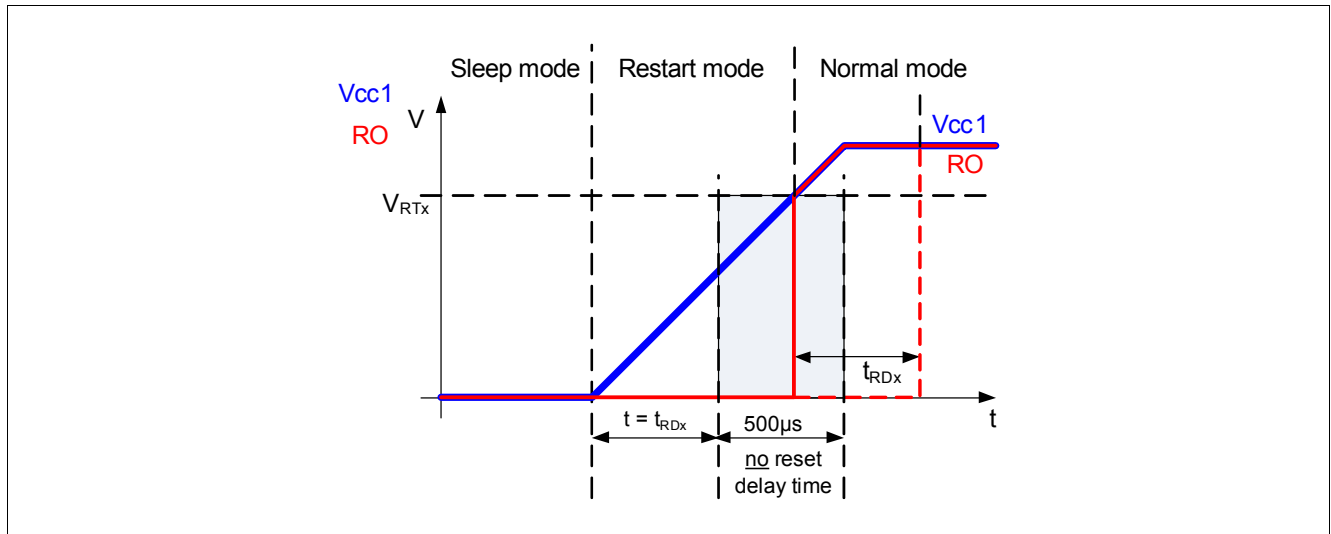
Figure 4 Missing reset delay time after coming from SBC Reset Mode

- During the ramp-up phase of  $V_{cc1\_μC}$  after a wake from SBC Sleep or Fail-Safe Mode at the transition from SBC Restart to SBC Normal Mode.
- The output voltage  $V_{cc1\_μC}$  reaches the selected  $V_{RTx}$  during a certain time window  $t_{RDx}$  and  $t_{RDx} + 500\ μs$  (because  $t_{RDx}$  is also used for the  $V_{cc1\_μC\_UV\_TO}$  detection - see also [Figure 4](#)). The timer for  $t_{RDx}$  is initially started when SBC Restart Mode is entered.
- Depends on slope of  $V_{cc1\_μC}$  during ramp-up, which is determined by external capacitor at  $V_{cc1\_μC}$ .

- Under conditions as described in [Chapter 3.1](#) no reset delay time will be triggered. See also [Figure 4](#)
- When  $V_{cc1\_μC}$  is ramping during SBC Restart Mode an internal counter starts running to test for the “Vcc1 undervoltage time-out” behavior. However, the same counter is used for the reset delay time  $t_{RDx}$ . See also [Chapter 3.3](#)

- When the counter content shows the end of the reset delay time when  $V_{cc1\_μC}$  is crossing the  $V_{RTx}$  threshold, RO is set to "HIGH" already after 10μs (typ) instead of configured  $t_{RDx}$

- The critical range in time (see Figure 4) is the period between  $t_{RDx}$  and  $t_{RDx} + 500 \mu s$
- When  $V_{cc1\_μC}$  exceeds  $V_{RTx}$  during that time, the reset delay time is skipped and RO is release already after 10μs (typ.)
- The critical range for the external capacitor at  $V_{cc1\_μC}$  and  $t_{RD2}$  selected can be calculated (assuming the capacitor is discharged):

- Select the long (default) reset delay time  $t_{RD1}$  (in that case  $C_{crit} > 185 \mu F$ ). Changing the reset delay time does not affect any other behavior of the SBC.
- The selected reset threshold  $V_{RTx}$  has a small influence only

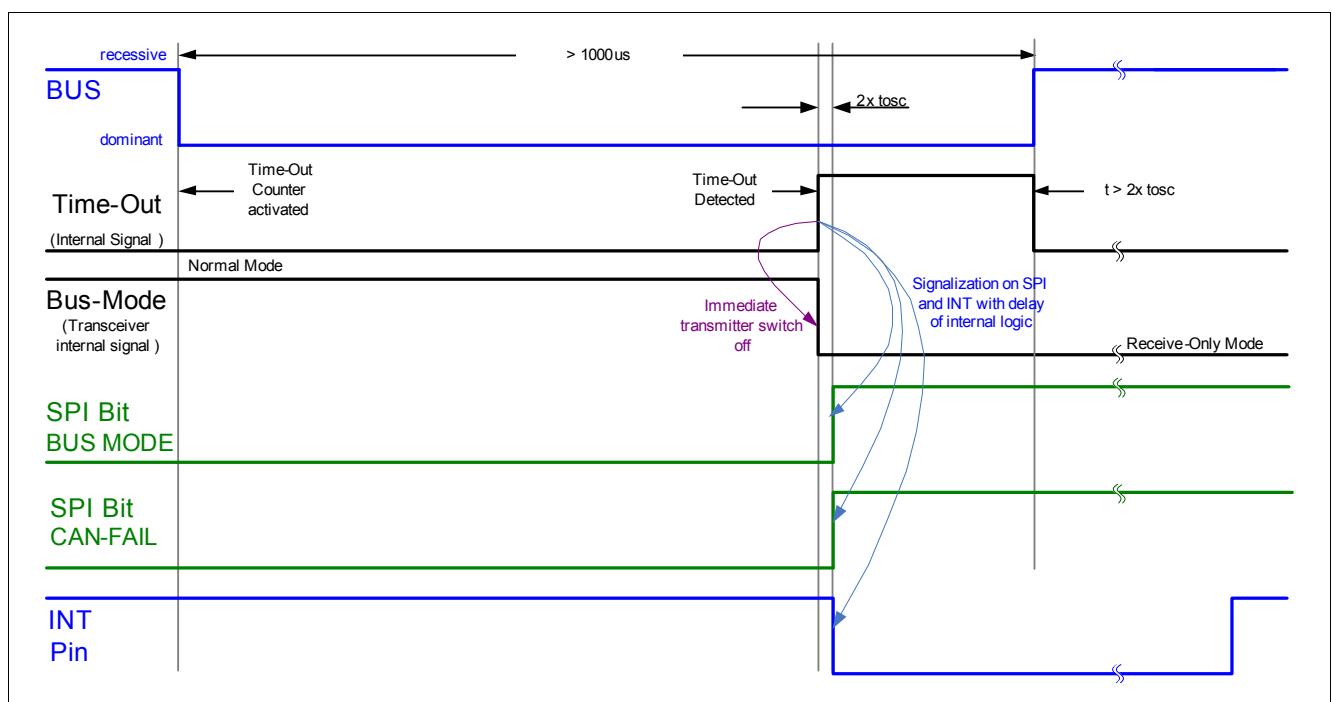
**Figure 5** Simplified timing diagram (not to scale) of a dominant CAN bus signal longer than  $t_{\text{BUS\_TO, max}}$   
The SPI CAN Fail Bit is set

The SPI bus failure bits are set accordingly if the detected time-out condition is valid for a sufficient time ( $>2$  clock cycles  $\approx 8\mu\text{s}$ ). As shown in **Figure 5**, this is the case if the dominant time-out condition is valid longer than the maximum time-out detection period  $t_{\text{BUS\_TO}}$ .

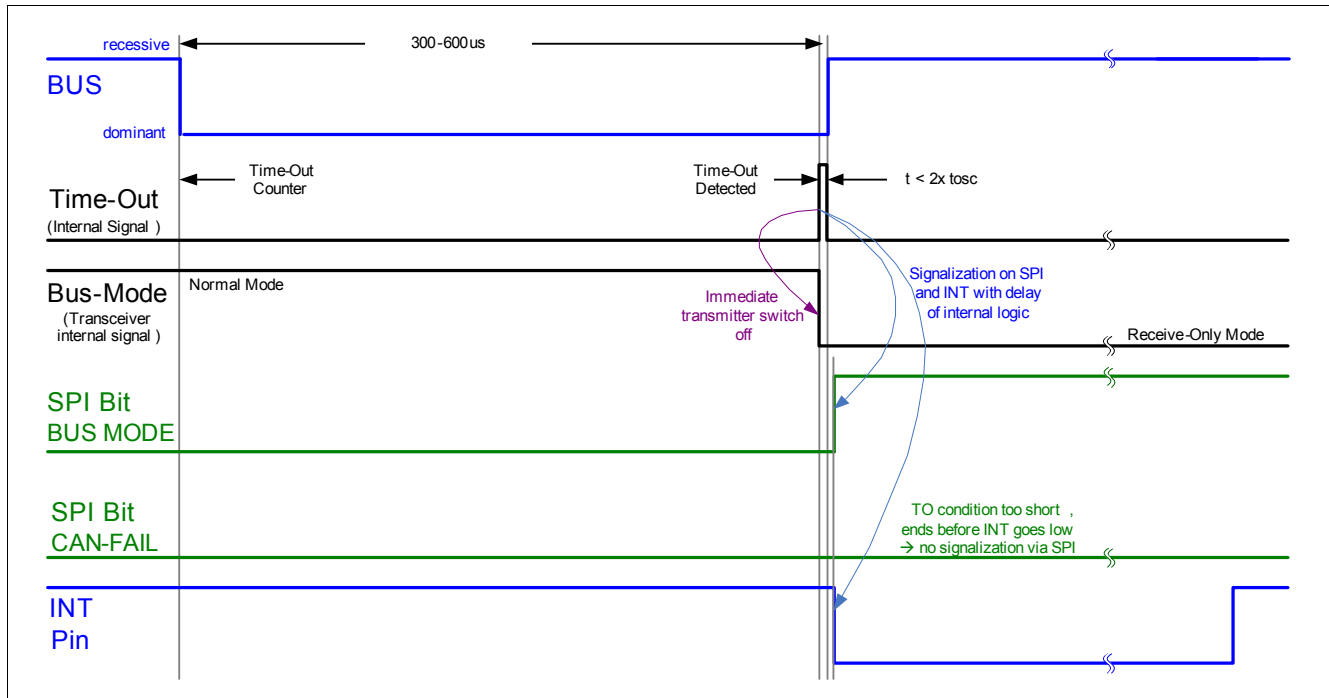
**Figure 6** Simplified timing diagram (not to scale) of a dominant CAN bus signal in the range of 300 -600us. No SPI CAN fail bit is set

However, it could occur that a CAN or LIN dominant time-out failure<sup>1)</sup> is not always set in the respective SPI register for pulses shorter than the maximum time-out detection period  $t_{\text{BUS\_TO}}$ .

If the time-out condition disappears shortly after the detection (1-2 clock cycles) it is possible that the SBC will capture the time-out event but not set the corresponding SPI flag. The INT pin is properly toggled, the transceiver is properly set into Receive Only Mode. However the SPI flag is not set. This behavior will occur for dominant CAN signals within the range of 300 $\mu\text{s}$  and 600 $\mu\text{s}$  (for LIN signals between 10ms and 14ms). A timing diagram showing this behavior is shown in **Figure 6**.

This behavior will also be seen when the transceiver is switched again to Normal Mode (from Receive Only Mode) during the dominant pulse and when the remaining dominant period falls within the above mentioned range.

- Read the status of the communication setup register (101) to check if the transceivers have changed modes (i.e. from Normal to Receive Only Mode).
- If this is the case, then a bus failure has occurred and the microcontroller must switch the transceiver back to normal mode if applicable.
- If the mode of the transceivers is unchanged, then another ghost interrupt has occurred caused by a register read out while INT was HIGH (not a bus dominant time-out). If the interrupt registers are all '0', then the INT trigger should be ignored by the software.
