Active Errata List

CAN Microcontrollers

T89C51CC01
T89C51CC01UA
T89C51CC01CA

Errata Sheet

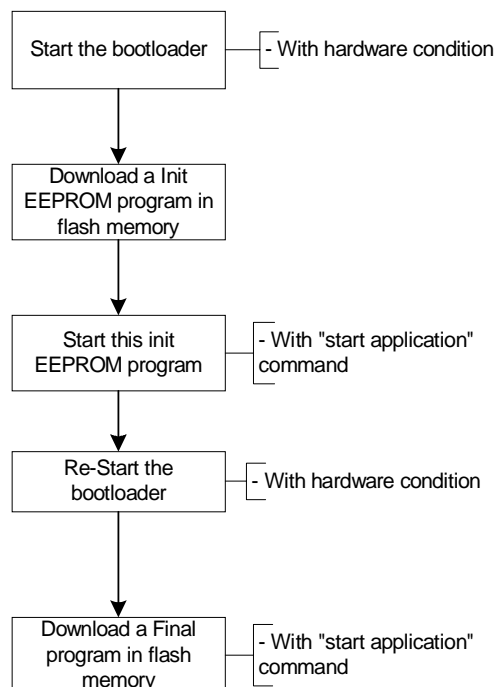
16. EEPROM – Lock-up during ISP write

Program lock-up can be experienced when using Atmel FLIP software or a custom In system Programming tools to write in the internal EEPROM. This problem occurs with clock frequency > 12MHz in X2 mode or 24MHz in X1 mode. Neither the code Flash nor the EEPROM are corrupted by the lock-up. Although the EEPROM cannot be written by the bootloader.

This problem is bootloader related and doesn't affect the capability for the user to read and write into the EEPROM. This problem is technology dependant. The likelihood of experiencing the problem is low at Clock frequency > 24 MHz in X1 mode and non-existent below. A reset can be applied to recover from the lock-up.

Workaround

The following process can be done to work around the problem.

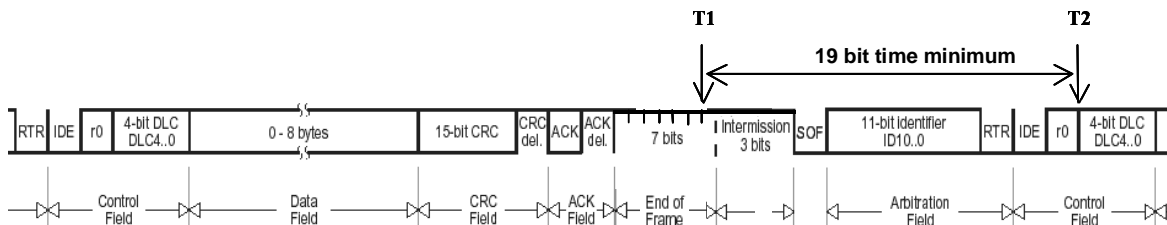
17. Transmission after a 3 bit Intermessage

If a Transmit Message Object (MOB) is enabled while the CAN bus is busy with an on going message, the transmitter will wait for the 3-bit Intermission before starting its transmission. This is in full agreement with the CAN recommendation.

1. At least one Receive MOB of the chip are programmed to accept the incoming message. In this case, the transmitter will wait for the next 3-bit Intermission to retry its transmission.
2. No Receive MOB of the chip are programmed to accept the incoming message. In this case the transmitter will wait for a 4-bit Intermission to retry its transmission. In this case, any other CAN nodes ready to transmit after a 3-bit Intermission will start transmit before the chip transmitter, even if their messages have lower priority IDs.

Workaround

Always have a Receive MOB enabled ready to accept any incoming messages. Thanks to the implementation of the CAN interface, a Receive MOB must be enable at latest, before the 1st bit of the DLC field. The Receive MOB status register is written (RXOK if message OK) immediately after the 6th bit of the End of Frame field. This will leave in CAN2.0A mode a minimum 19-bit time delay to respond to the end of message interrupt (RXOK) and re-enable the Receive MOB before the start of the DLC field of the next incoming message. This minimum delay will be 39-bit time in CAN2.0B. See CAN2.0A CAN2.0B frame timings below.

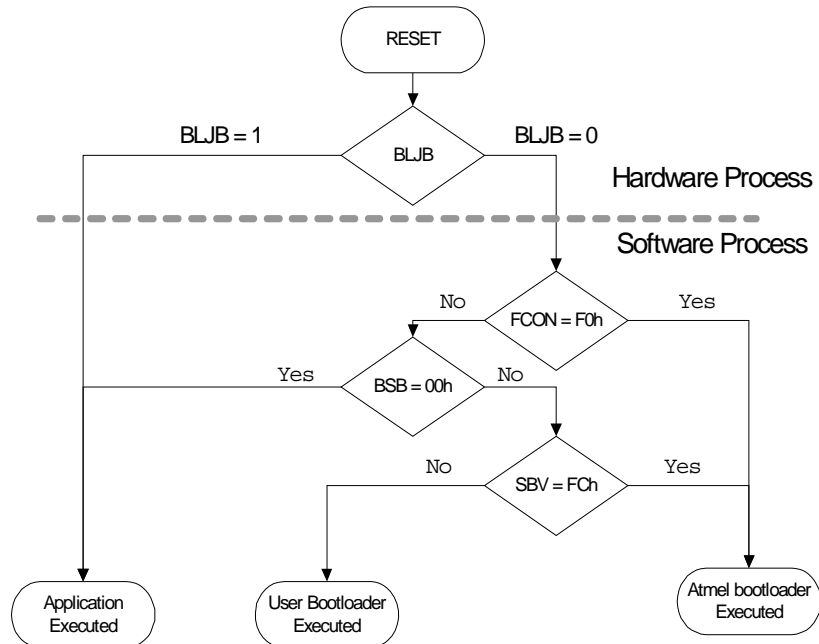
Version 1.2:

4. Boot Process Compatibility

There are some differences between Boot process of bootloader 1.2 and newer versions (see below).

Workaround

Use the fuse bit BLJB to start the application in both versions.
