## CAN Microcontrollers

**T89C51CC02**

## Errata Sheet

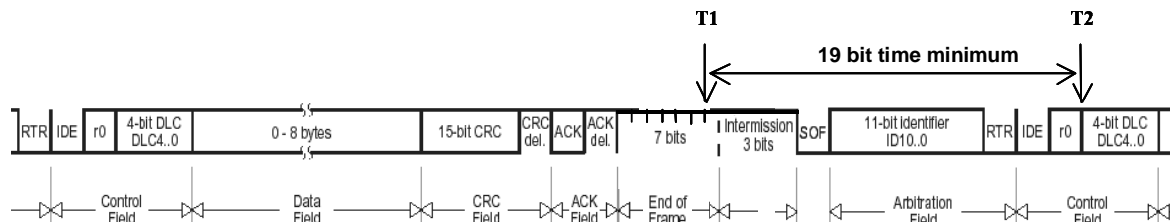
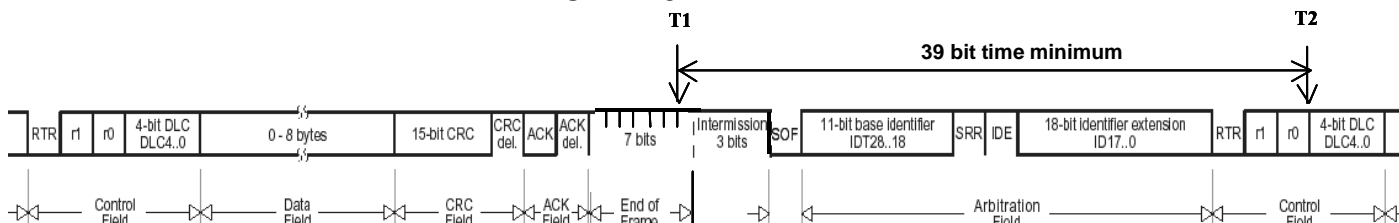
If a Transmit Message Object (MOB) is enabled while the CAN bus is busy with an on going message, the transmitter will wait for the 3-bit Intermission before starting its transmission. This is in full agreement with the CAN recommendation.

If the transmitter lost arbitration against another node, two conditions can occur :

1. At least one Receive MOB of the chip are programmed to accept the incoming message. In this case, the transmitter will wait for the next 3-bit Intermission to retry its transmission.
2. No Receive MOB of the chip are programmed to accept the incoming message. In this case the transmitter will wait for a 4-bit Intermission to retry its transmission. In this case, any other CAN nodes ready to transmit after a 3-bit Intermission will start transmit before the chip transmitter, even if their messages have lower priority IDs.

Always have a Receive MOB enabled ready to accept any incoming messages. Thanks to the implementation of the CAN interface, a Receive MOB must be enable at latest, before the 1<sup>st</sup> bit of the DLC field. The Receive MOB status register is written (RXOK if message OK) immediately after the 6<sup>th</sup>-bit of the End Of Frame Field. This will leave in CAN2.0A mode a minimum 19-bit time delay to respond to the end of message interrupt (RXOK) and re-enable the Receive MOB before the start of the DLC field of the next incoming message. This minimum delay will be 39-bit time in CAN2.0B. See CAN2.0A CAN2.0B frame timings below.

The workaround is to have the last MOB (MOB3) as "spy" enabled all the time; it is the MOB of lowest priority : If a Mob other than MOB3 is programmed in receive mode and its acceptance filter matches with the incoming message ID, this Mob will take the message. MOB3 will only take messages than no other MOBs will have accepted. MOB3 will need to be re-enabled fast enough to manage back to back frames. The deadline to do this is the beginning of DLC slot of incoming frames as explained above.
