Change in Lead Frame Material

< Affected products: DIP package products of Discrete Division produced at Oita Operations >

Date: June 26, 2015
Toshiba Corporation
Semiconductor & Storage
Products Company

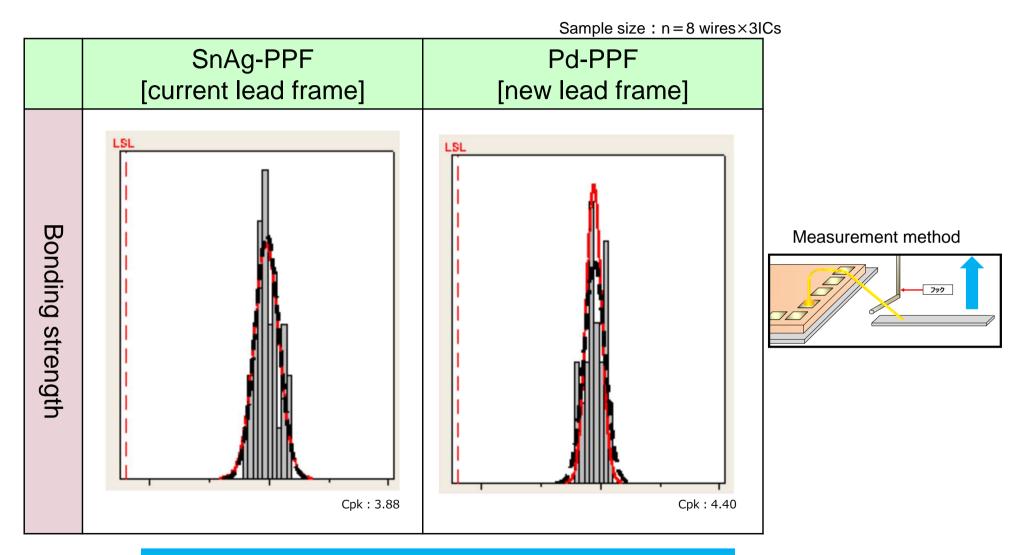
-Evaluation Data of Bondability on Inner Lead Side at Wire Bonding Process

No problem without significant difference from the current lead frame

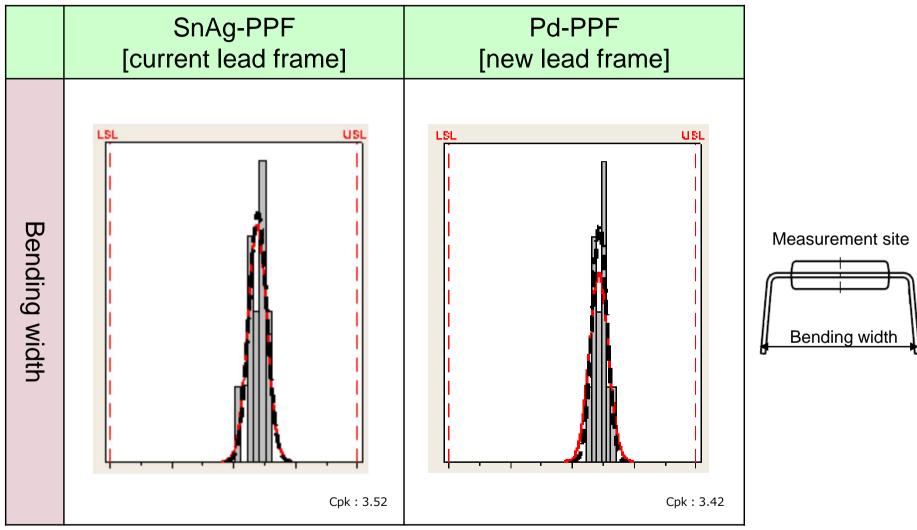
- Evaluation Data of Bending Width at Lead Trim & Forming Process

No problem without significant difference from the current lead frame

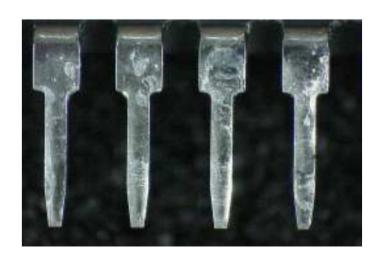
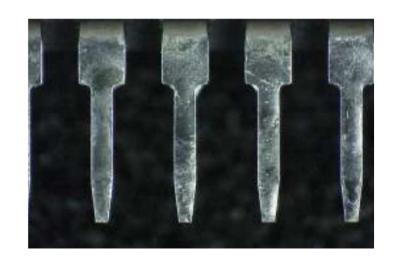
- Solderability Test Data

Test item	Sample size	Test result (reject/gross)
Solderability	12pcs	0/12pcs

SnAg-PPF [current lead frame]

Pd-PPF [new lead frame]

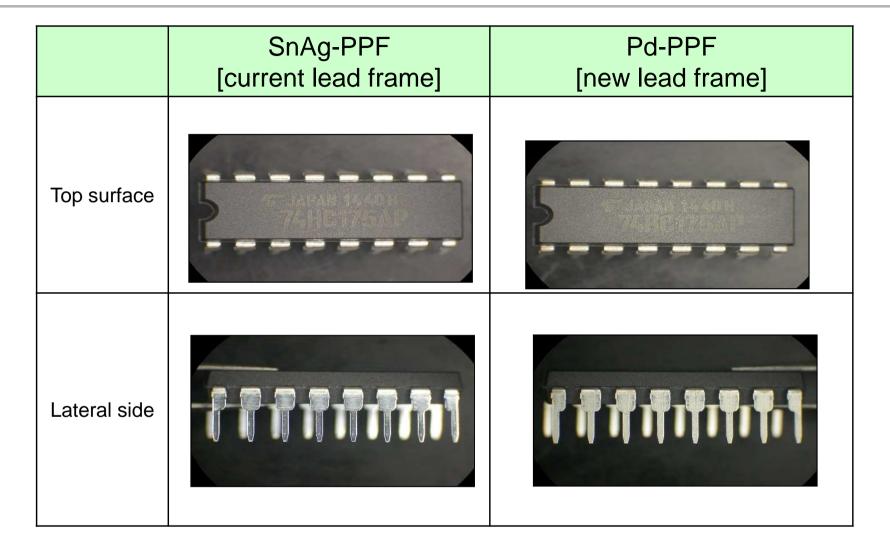
- Package Appearance Comparison

No problem in marking visibility without significant difference from the current package Slight difference in gloss of outer leads is due to difference in plating composition.
