Test Report

Report No. A225036410210100402R1

Sample Name SMA Bulkhead Jack with O-ring, PCB mount, Right angle
Part number RFPC-SMA41-FN
Sample Receiving State Normal
Sample Received Date May 28, 2025
Testing Period May 28, 2025-Jun. 16, 2025

No.	Test Item
1	IP6X

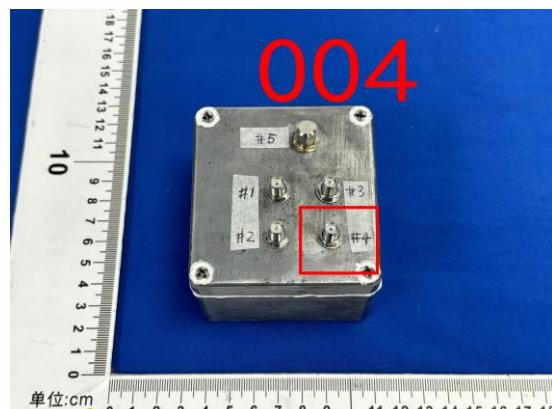
Sample No.	Sample Name	Quantity
A2250364102101004	SMA Bulkhead Jack with O-ring, PCB mount, Right angle	1pc

Sample Photo(s)

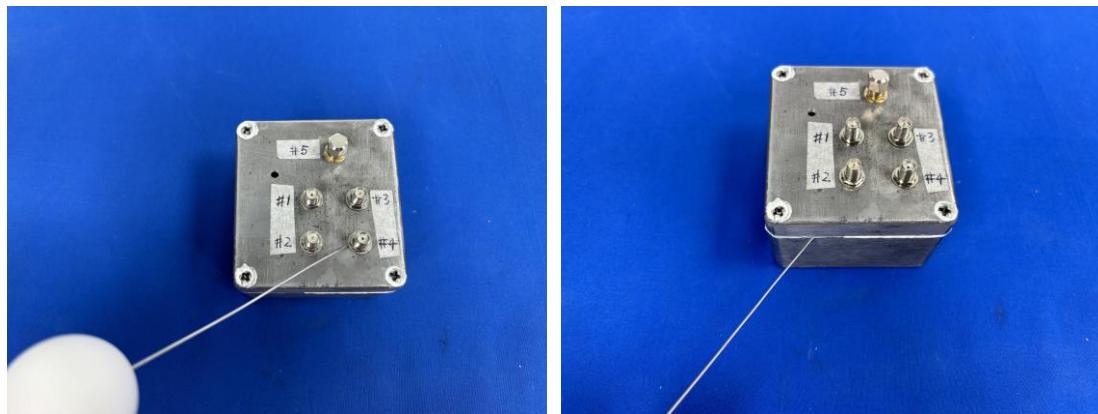
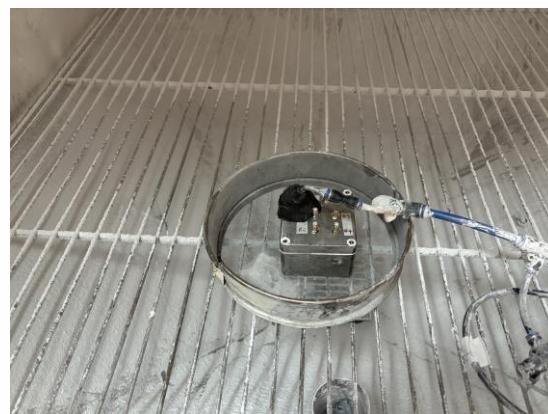
Use a test probe with a diameter of 1mm to probe the gap part of the sample with a force of 1N.

Put the sample in a negative pressure state, the pumping rate is 40-60 times the volume of the shell per hour, and the pressure difference between the pressure in the shell and the atmospheric pressure is less than 2kPa, and the test is continuously performed for 2h in the dust-proof test box.

Test Photo(s)

Sample No.	Criterion	Test result (Visual inspection)	Conclusion
A2250364102101004	The test probe cannot enter the inside of the sample, and the inside of the sample is dustless.	The test probe cannot enter the inside of the sample, and the inside of the sample is dustless.	Pass

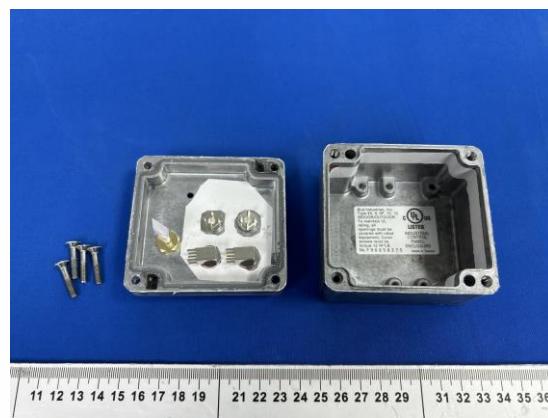
A2250364102101004

**Sample Photo(s) after the test**
