Test Report

Report No. A225036410210100302R1

Sample Name RP SMA Bulkhead Jack with O-ring, PCB mount, Right angle
Part number RFPC-SMA43-FN
Sample Receiving State Normal
Sample Received Date May 28, 2025
Testing Period May 28, 2025-Jun. 16, 2025

No.	Test Item
1	IP6X

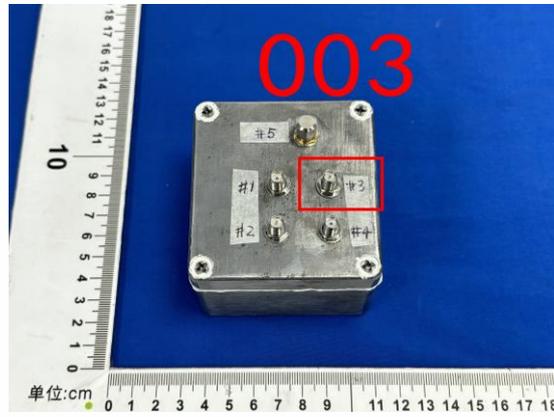
Sample No.	Sample Name	Quantity
A2250364102101003	RP SMA Bulkhead Jack with O-ring, PCB mount, Right angle	1pc

Sample Photo(s)

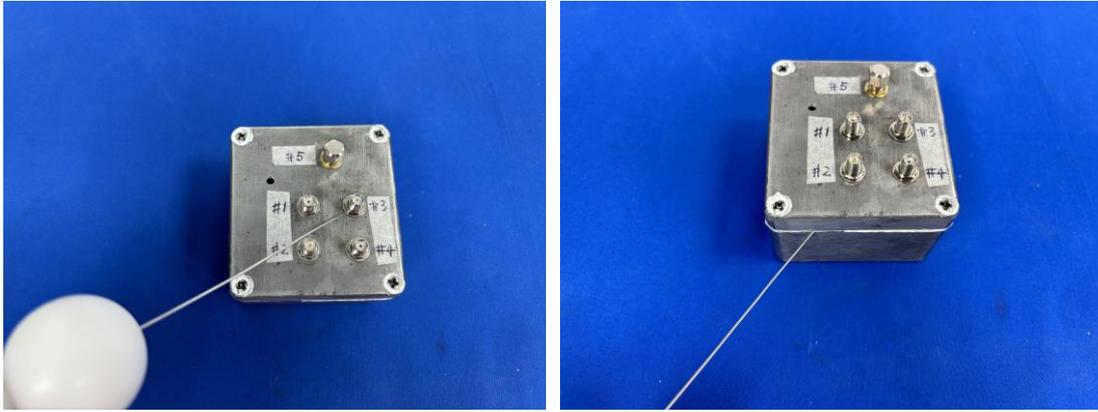
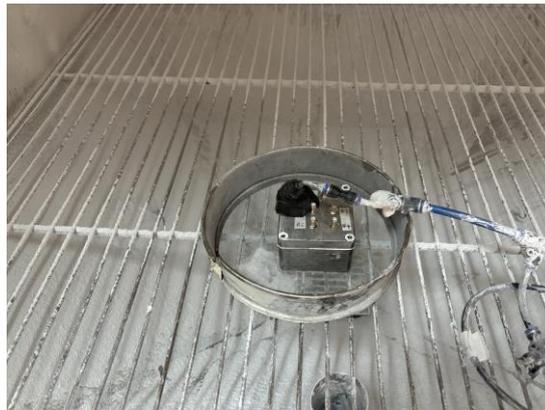
Use a test probe with a diameter of 1mm to probe the gap part of the sample with a force of 1N.

Put the sample in a negative pressure state, the pumping rate is 40-60 times the volume of the shell per hour, and the pressure difference between the pressure in the shell and the atmospheric pressure is less than 2kPa, and the test is continuously performed for 2h in the dust-proof test box.

Test Photo(s)

Sample No.	Criterion	Test result (Visual inspection)	Conclusion
A2250364102101003	The test probe cannot enter the inside of the sample, and the inside of the sample is dustless.	The test probe cannot enter the inside of the sample, and the inside of the sample is dustless.	Pass

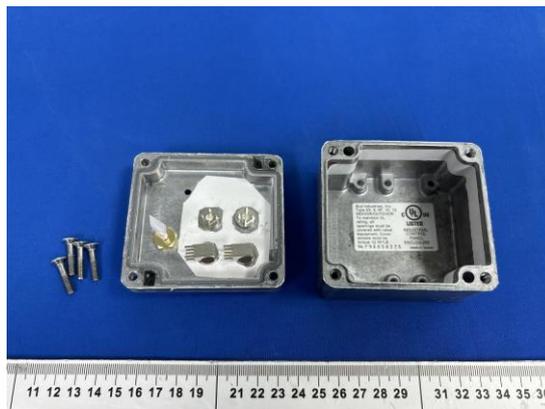
A2250364102101003

Sample Photo(s) after the test
