Test Report

Report No. A224025207220100102

Sample Name Type C Receptacle, Vertical, SMT Type,
24Pin
Model No. USB4725-XX-C
Sample Receiving State Normal
Sample Received Date May 7, 2024
Testing Period May 7, 2024-May 13, 2024

No.	Test Item
1	IP6X

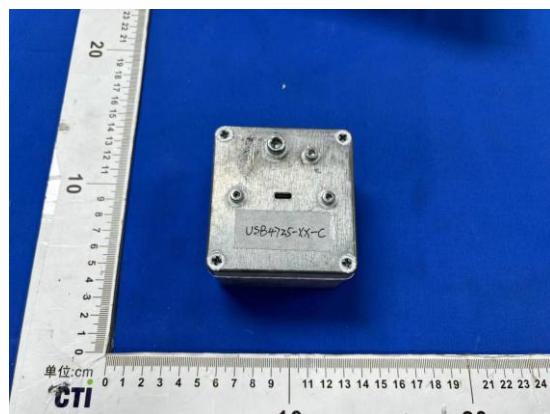
Sample No.	Sample Name	Type	Quantity
A2240252072201001	Type C Receptacle, Vertical, SMT Type, 24Pin	USB4725-XX-C	1pc

Sample Photo(s)

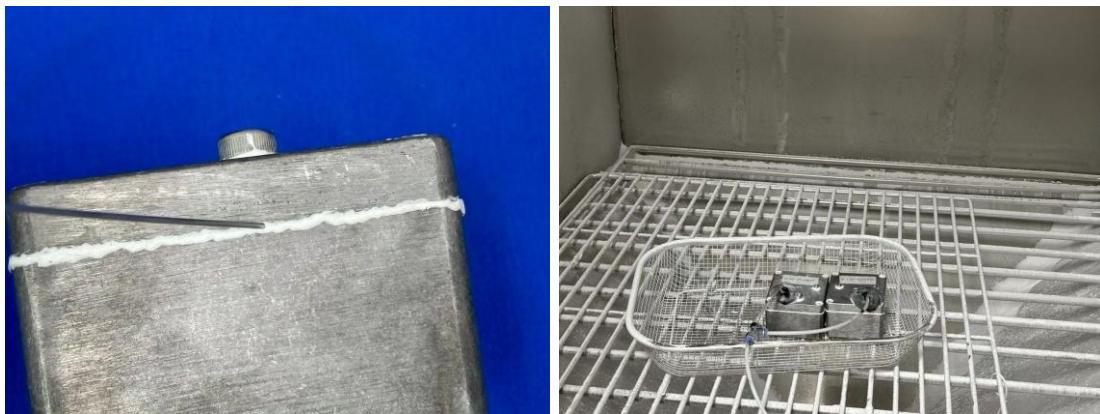
Use a test probe with a diameter of 1mm to probe the gap part of the sample with a force of 1N.

Put the sample in a negative pressure state, the pumping rate is 40~60 times the volume of the shell per hour, and the pressure difference between the pressure in the shell and the atmospheric pressure is less than 2kPa, and the test is continuously performed for 2h in the dust-proof test box.

Test Photo(s)

Sample No.	Criterion	Test result (Visual inspection)	Conclusion
A2240252072201001	The test probe can not enter into the sample, No dust enters inside the sample.	The test probe cannot enter the inside of the sample, and the inside of the sample is dustless.	Pass
