PART NUMBER 0ED-S15396

REV.	PART NUMBER
С	0ED-SI5396
	PHOTO INTERRUPTER.

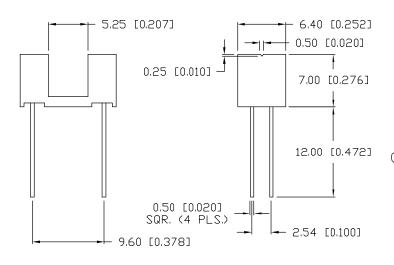
TOP VIEW PIN LAYOUT
