dsPIC33EVXXXGM00X/10X Family Silicon Errata and Data Sheet Clarification

The dsPIC33EVXXXGM00X/10X family devices that you have received conform functionally to the current Device Data Sheet (DS70005144H), except for the anomalies described in this document.

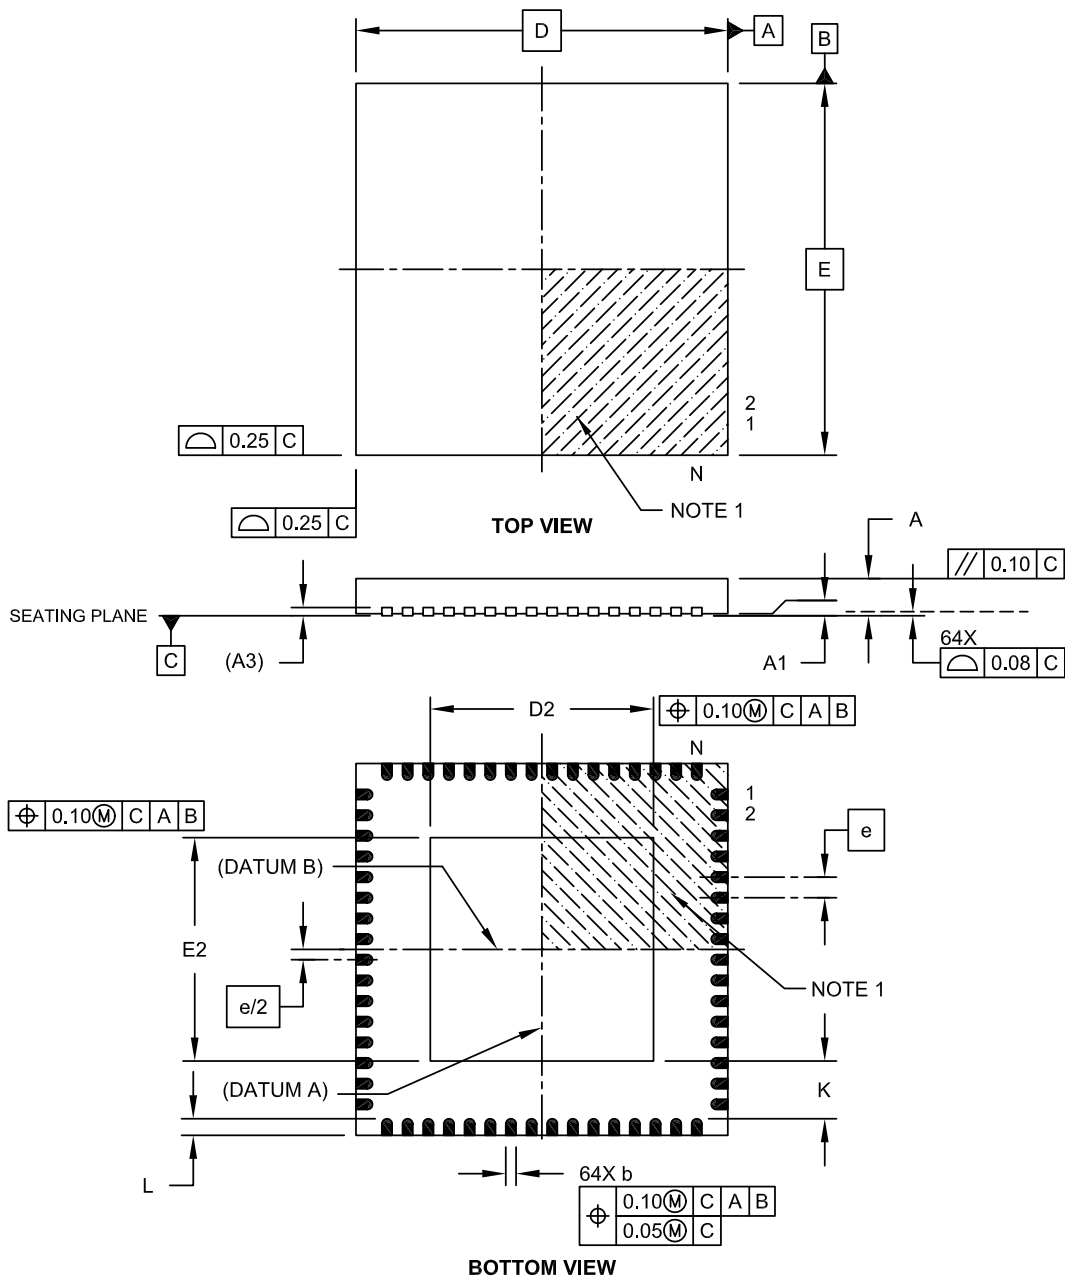
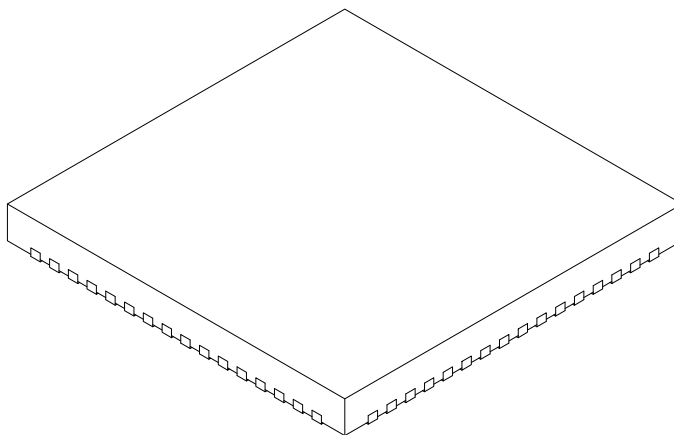
64-Lead Plastic Quad Flat, No Lead Package (MR) – 9x9x0.9 mm Body with 5.40 x 5.40 Exposed Pad [QFN]

The package drawing for the 64-pin QFN device has been updated with the 64-Lead Plastic Quad Flat, No Lead package (MR) – 9x9x0.9 mm Body with 5.40x5.40 Exposed Pad [QFN] package drawing as shown below.

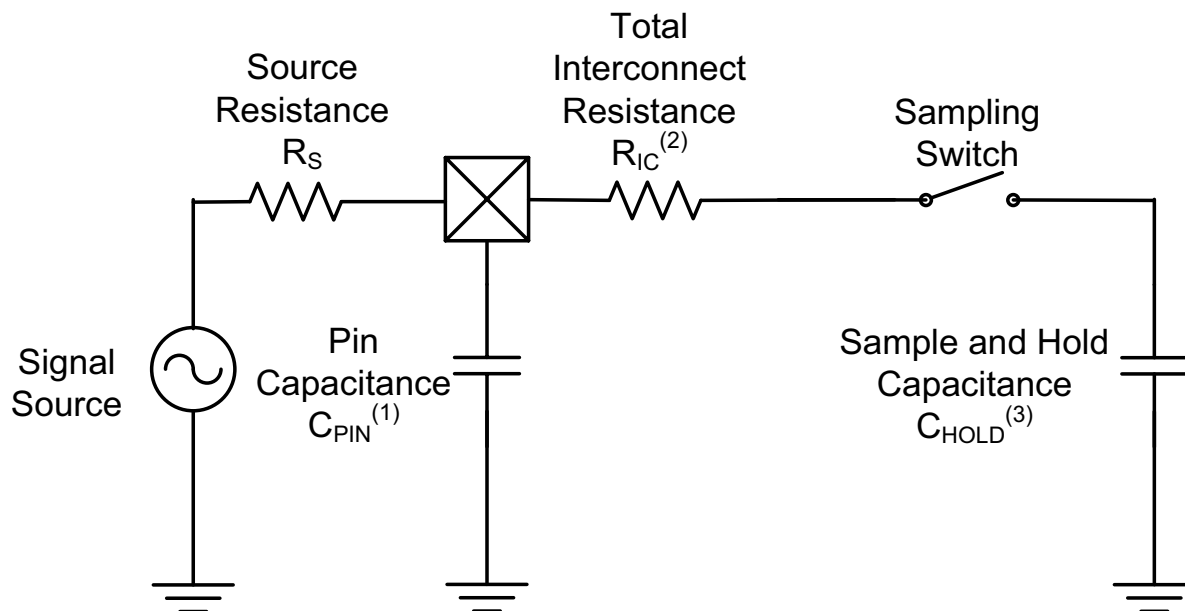
Figure 24-3. ADC Input Model

Note 1: The C_{PIN} value depends on the device package and is not tested. For QFN or TQFP packages, the typical value is about 4 pF.

2: The typical value of R_{IC} is less than 10 k Ω .
