Desktop 3rd Generation Intel® Core™ Processor Family

Specification Update

May 2013

Revision 011

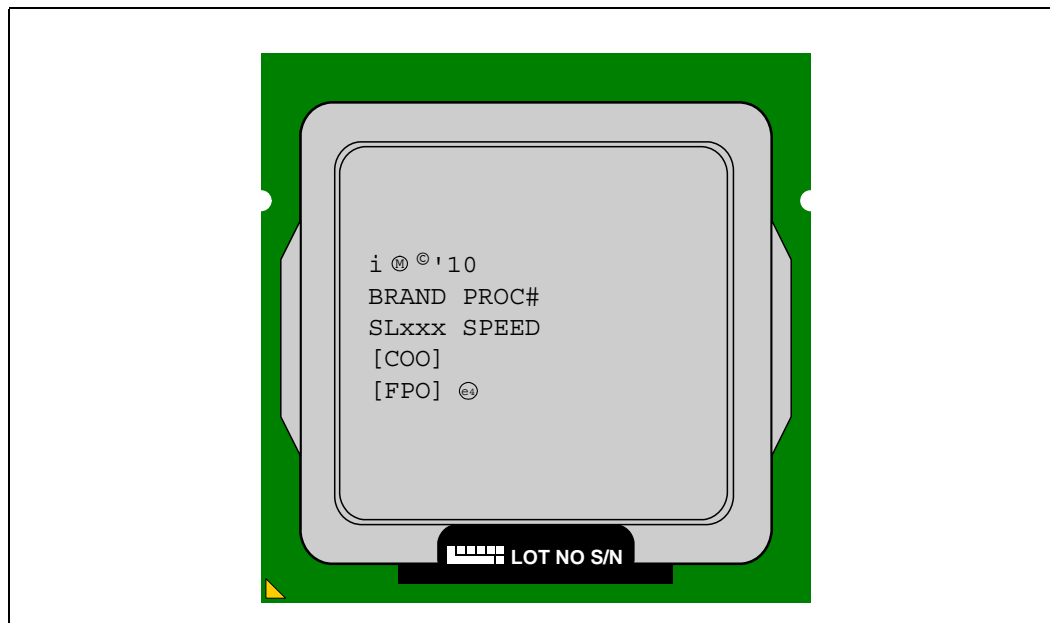
Figure 1. Processor Production Top-side Markings (Example)

The processor stepping can be identified by the following component markings.
