# **Intel® 82574 Family Gigabit Ethernet Controller Specification Update**

*June 2012  
Revision 3.7*

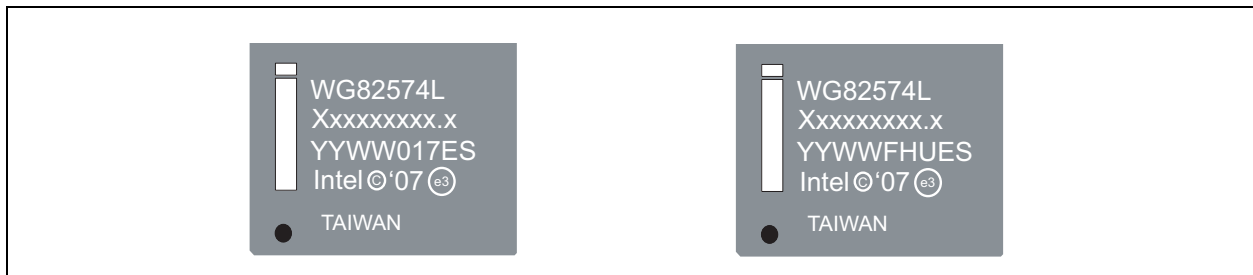
**Figure 1. Engineering Samples Top Marking Example With Identifying Marks**

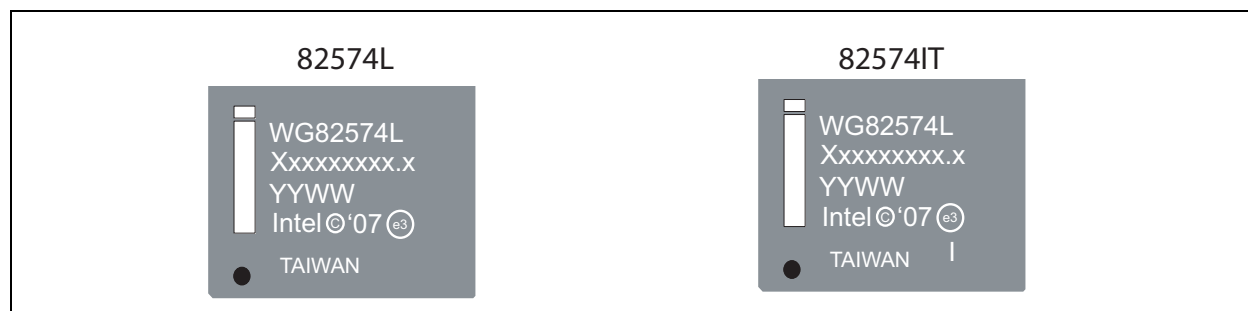
**Figure 2. Production Top Marking Example With Identifying Marks**

1. See [Figure 2](#).
