Intel® 82583V Gigabit Ethernet Controller Specification Update

*June 2012
Revision 2.9*

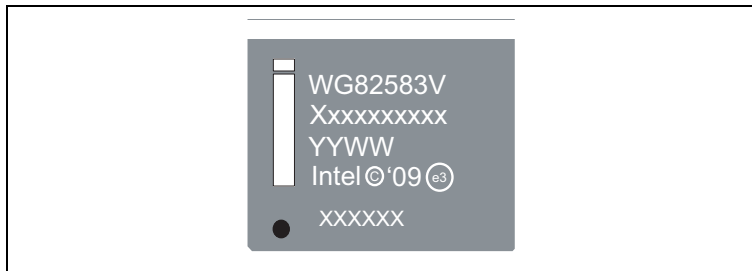
Figure 1. Top Marking Example With Identifying Marks
Notes:

Line 1: Marketing Name (WG82583V)
 Line 2: TSMC Fab Lot Number "XXXXXXXX" or "XXXXXXXX.x"
 Line 3: Assembly Date Code "YYWW"
 Line 4: "INTEL", © Copyright including two number date code, circled "e3" lead-free mark
 Line 5: Country of Origin
