# Intel<sup>®</sup> Atom<sup>™</sup> Processor Z5xx Series

## Specification Update

*Intel<sup>®</sup> Atom<sup>™</sup> processor Z550, Z540, Z530, Z520, Z515, Z510,  
and Z500 on 45-nm process technology*

*Revision 013*

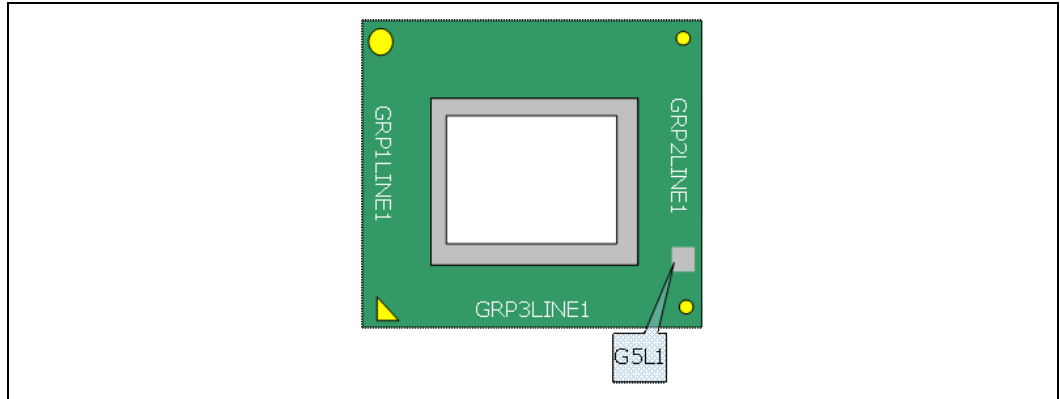
**Figure 1. Intel® Atom™ Processor Z5xx Series (Micro-FCBGA) Markings**

Intel® Atom™ processor Z5xx series may be identified by the following component markings.

GRP1LINE1: INTEL {M}©'07 {e1}  
GRP2LINE1: <Level-4 Name><FSB>  
GRP3LINE1: {FPO} S-SPEC  
G5L1: 2D Matrix
