# **Intel<sup>®</sup> Xeon<sup>®</sup> Processor E3-1200 v2 Product Family**

**Specification Update**

*May 2012*

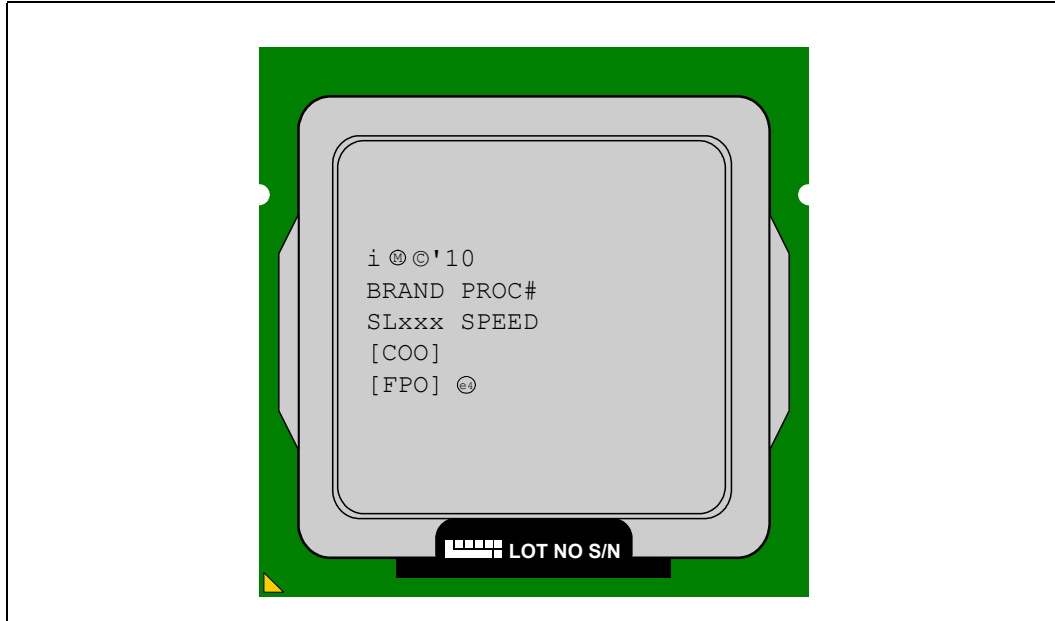
**Figure 1. Processor Production Top-side Markings (Example)**

The processor stepping can be identified by the following component markings.
