# Mobile/Desktop 5th Generation Intel<sup>®</sup> Core<sup>™</sup> Processor Family

Specification Update

*Supporting the 5th Generation Intel<sup>®</sup> Core<sup>™</sup> Processor based on  
Mobile H-Processor Line and Desktop H-Processor Line*

*Revision 018*

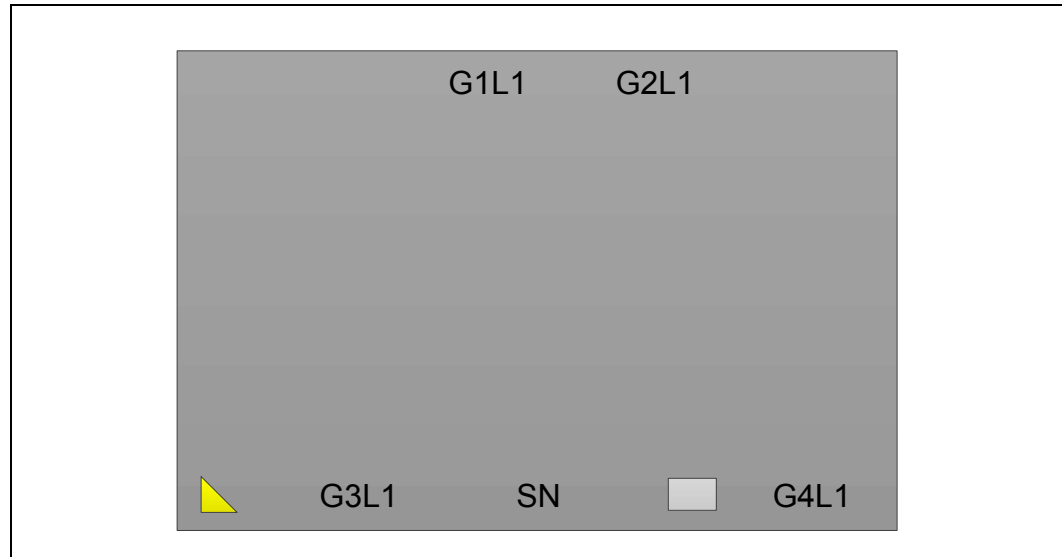
**Figure 1. Mobile H-Processor Line BGA Top-Side Markings**

The processor stepping can be identified by the following component markings.

Pin Count: 1364      Package Size: 37.5 mm x 32 mm

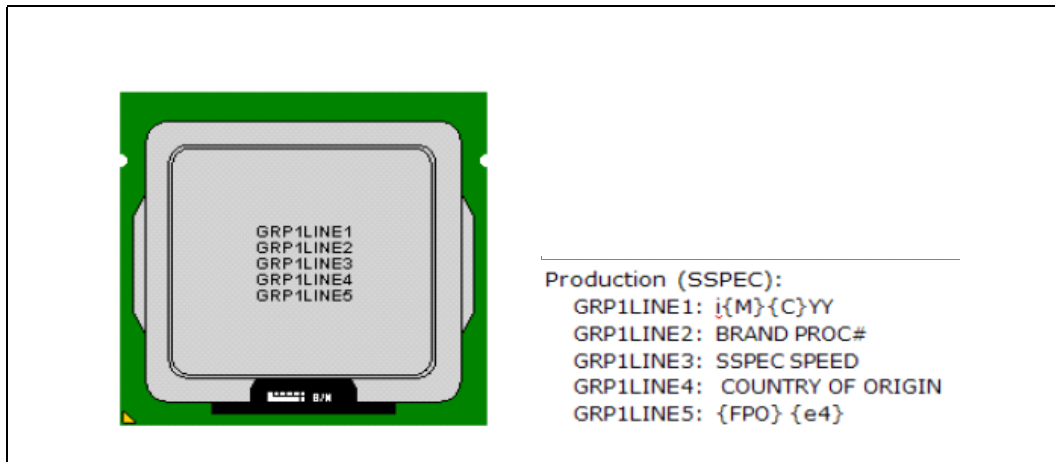
**Figure 2. Desktop H-Processor Line LGA Top-Side Markings**

Pin Count: 1150 Package Size: 37.5 mm x 37.5 mm
