LAN8804 Silicon Errata and Data Sheet Clarification

This document describes known silicon errata for the LAN8804 family of devices, which includes the following:

- LAN8804/ZMX
- LAN8804-V/ZMX

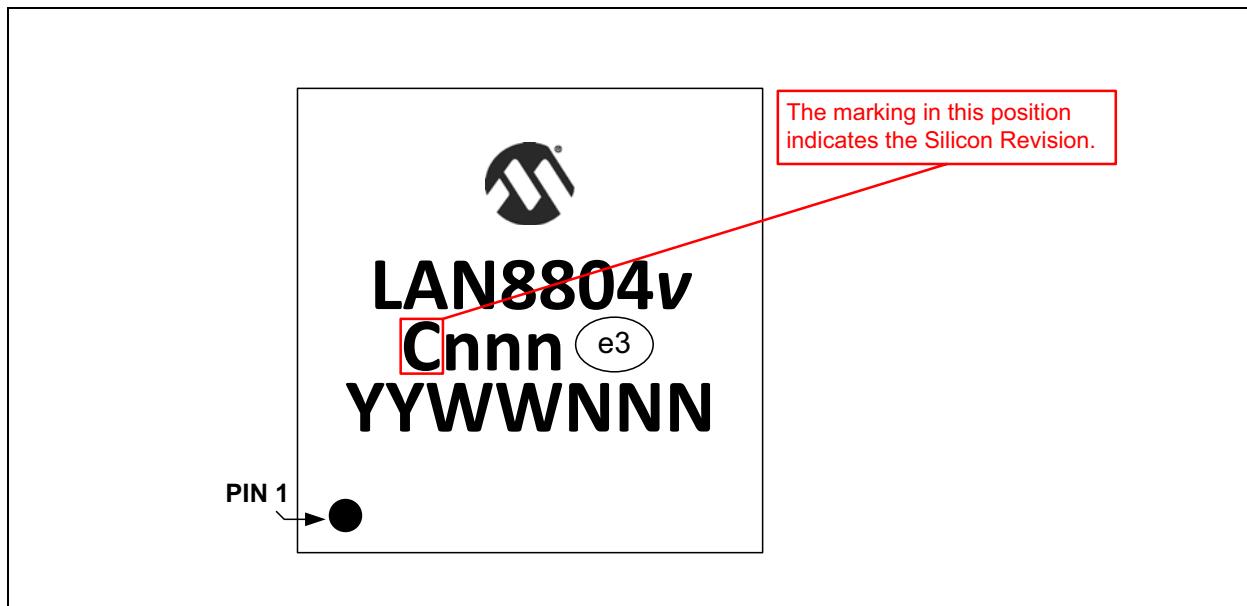
FIGURE 1: TOP MARKING DATE CODE INDICATION

Note: The purpose of [Figure 1](#) is to detail the top markings of an example part and highlight the location of the date code. Other top marking values may differ (lot codes, location of manufacture, etc.).

The silicon errata discussed in this document are for silicon revision(s) listed in [Table 1](#). The silicon revision can be determined by the device's top marking as indicated in [Figure 1](#). A summary of LAN8804 silicon errata is provided in [Table 2](#).
