Silicon Errata and Data Sheet Clarifications

The LAN8670/1/2 devices that you have received conform functionally to the Device Data Sheet (DS60001573J), except for the anomalies described in this document.

LAN8670/1/2

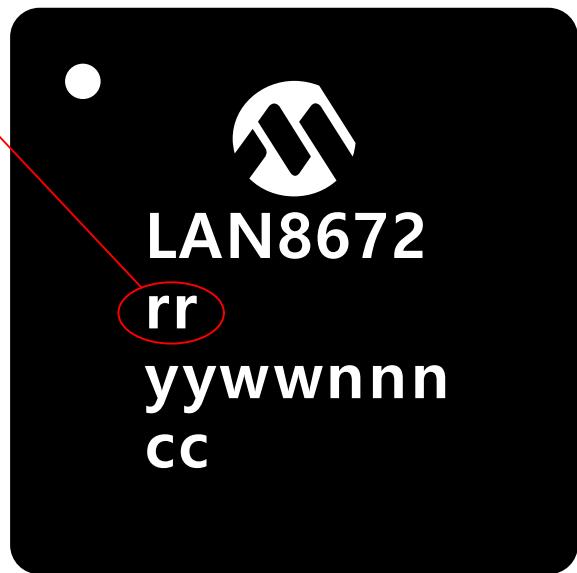
FIGURE 3: TOP MARKING FOR LAN8672 DEVICE

Marking in this position
indicates product revision
