Intel® Ethernet Controller X710-TM4/AT2 and V710-AT2

Specification Update

August 2023

Revision 2.4
615119-016

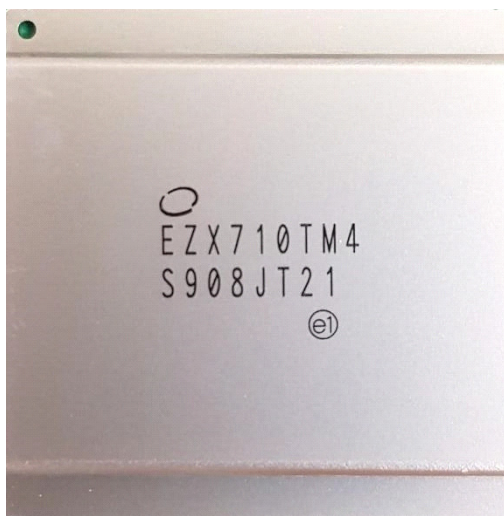
Figure 1-1. Example Component with Identifying Marks
