# 5th Generation Intel<sup>®</sup> Core<sup>™</sup> Processor Family, Intel<sup>®</sup> Core<sup>™</sup> M Processor Family, Mobile Intel<sup>®</sup> Pentium<sup>®</sup> Processor Family, and Mobile Intel<sup>®</sup> Celeron<sup>®</sup> Processor Family

Specification Update

*Revision 015*

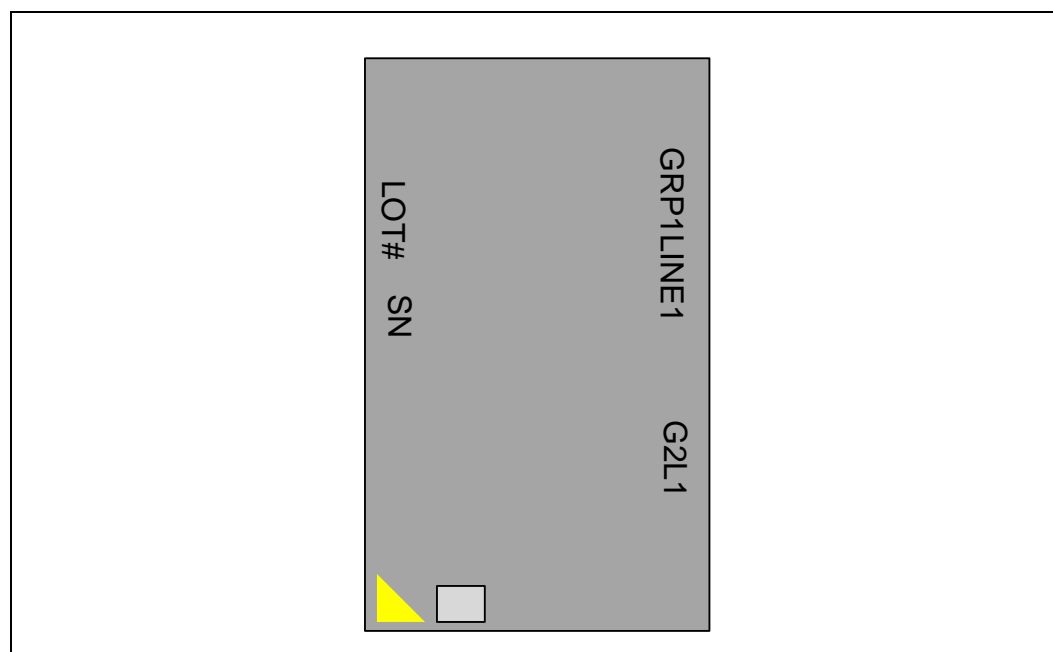
**Figure 1. 5th Generation Intel® Core™ Processor Family, Mobile Intel® Pentium® Processor Family, and Mobile Intel® Celeron® Processor Family Multi-Chip Package BGA Top-Side Markings**

Pin Count: 1168

Package Size: 40 mm x 24 mm

The processor stepping can be identified by the following component markings.

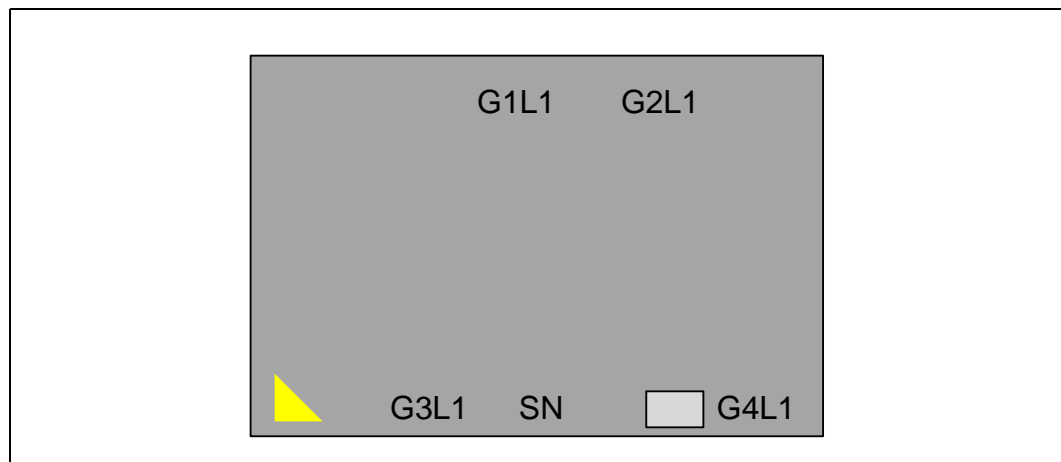
**Figure 2. Intel® Core™ M Processor Family Multi-Chip Package BGA Top-Side Markings**

Pin Count: 1234

Package Size: 30 mm x 16.5 mm
