# PRODUCT / PROCESS CHANGE NOTIFICATION

| 1.2 PCN No. | AMS/23/14070 |
| 1.3 Title of PCN | Bumping Process Change |

# Internal Reliability Evaluation Report

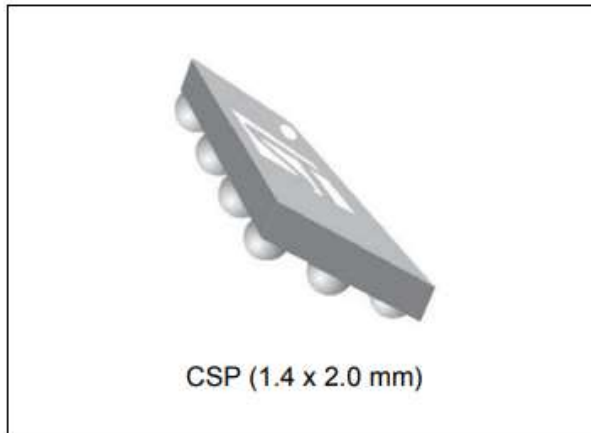
### 4.1 Device description

The GG25L includes the hardware functions required to implement a low-cost gas gauge for battery monitoring. The GG25L uses current sensing, Coulomb counting and accurate measurements of the battery voltage to estimate the state-of-charge (SOC) of the battery. An internal temperature sensor simplifies implementation of temperature compensation.

An alarm output signals a low SOC condition and can also indicate low battery voltage. The alarm threshold levels are programmable.

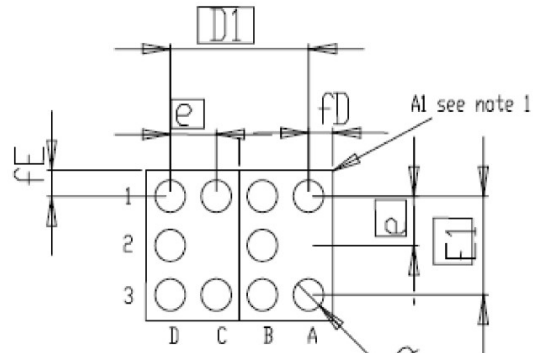
#### 6.1.1 Pin connection

Table 2. GG25L pin description

| Pin n° | CSP bump | Pin name | Type <sup>(1)</sup> | Function |

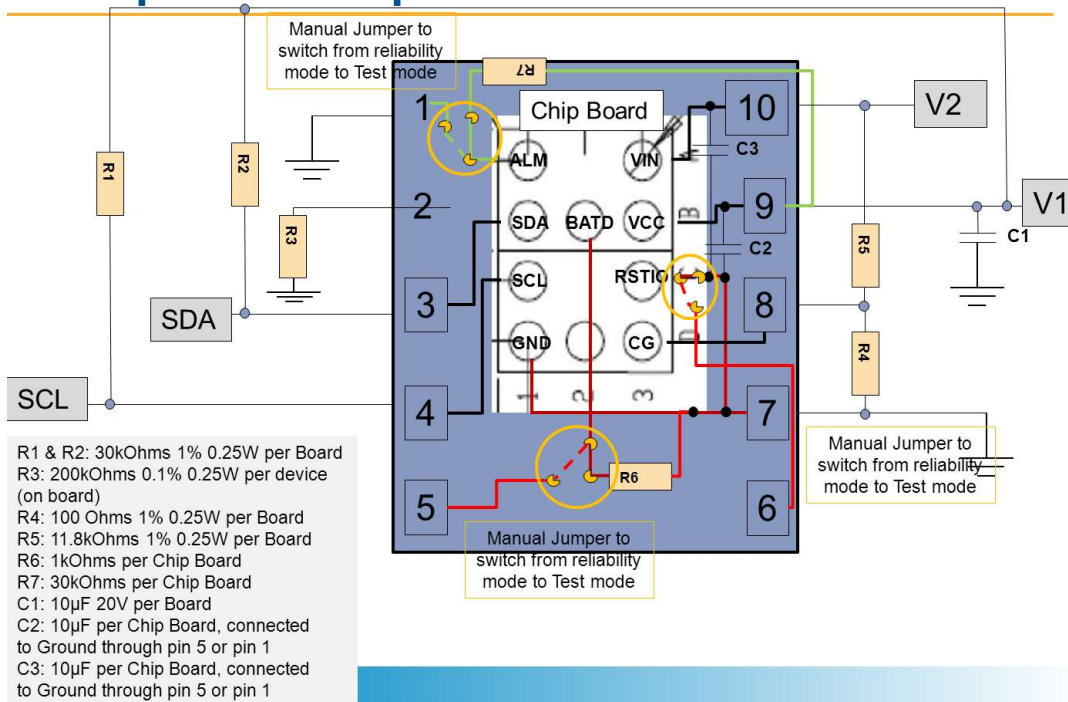
THB + Chip Board schematic

### 6.3 Test and reliability board Schematics
