Test Report

Report No. A225036410210100401R1

Sample Name SMA Bulkhead Jack with O-ring, PCB mount, Right angle
Part number RFPC-SMA41-FN
Sample Receiving State Normal
Sample Received Date May 28, 2025
Testing Period May 28, 2025-Jun. 16, 2025

Test Item: IPX7**1. Test Equipment**

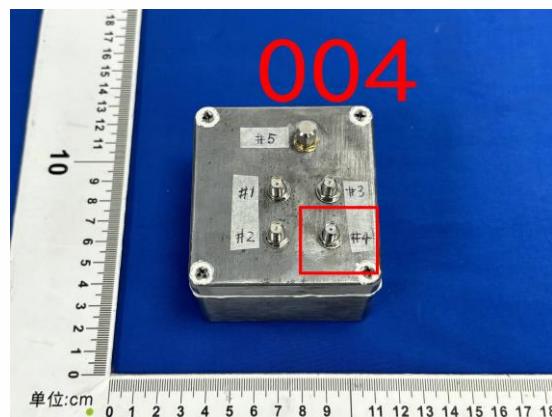
Sample No.	Sample Name	Quantity
A2250364102101004	SMA Bulkhead Jack with O-ring, PCB mount, Right angle	1pc

Sample Photo(s)

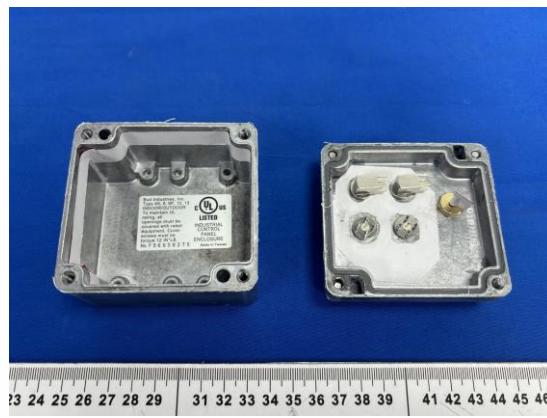
The lowest point of the sample is located 1000 mm below the surface of the water.

Test duration: 30min

Sample No.	Criterion	Test result (Visual inspection)	Conclusion
A2250364102101004	There is no water inside the sample.	No water enters the sample	Pass

Sample Photo(s) after the test
