# Test Report

Report No. A225036410210100301R1

Sample Name RP SMA Bulkhead Jack with O-ring, PCB mount, Right angle  
Part number RFPC-SMA43-FN  
Sample Receiving State Normal  
Sample Received Date May 28, 2025  
Testing Period May 28, 2025-Jun. 16, 2025

No.	Test Item
1	IPX7

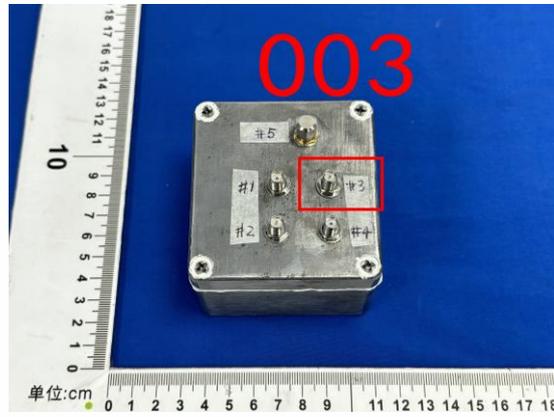
Sample No.	Sample Name	Quantity
A2250364102101003	RP SMA Bulkhead Jack with O-ring, PCB mount, Right angle	1pc

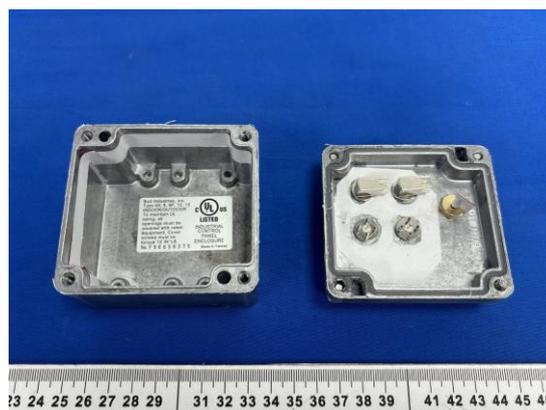
The lowest point of the sample is located 1000 mm below the surface of the water.

Test duration: 30min

Sample No.	Criterion	Test result ( Visual inspection )	Conclusion
A2250364102101003	There is no water inside the sample.	No water enters the sample	Pass
