**TECHNICAL DATA**

## Fluke ii910 and ii900 Acoustic Imagers

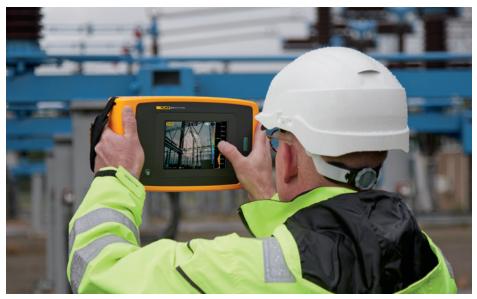
Image taken of the ii910 Precision Acoustic Imager detecting partial discharge in a high voltage application.

Partial Discharge is a very serious issue that you would like to be able to monitor quickly and easily. Whether you are inspecting insulators, transformers, switch gears or high voltage powerlines you need to be sure that you spot a problem quickly and early. Partial discharge that goes unchecked can cause blackouts, fires, explosions, or death from arc flashes. In addition to the danger that partial discharge poses to human lives and the environment, there is a significant monetary risk of downtime. Having equipment go down can cost millions of dollars per hour of downtime.

The Fluke ii910 Precision Acoustic Imager is the perfect tool for high voltage electricians, electrical test engineers, and grid maintenance teams that are constantly inspecting and maintaining power distribution and industrial high voltage equipment. The ii910 provides a safe quick and easy way to detect and locate partial discharge in order to maintain high voltage equipment and prevent catastrophic events. With the SoundSight™ technology the ii910 translates the sounds that it hears into a visual representation so that you can quickly locate problem areas. The higher frequency capability of the ii910 allows for earlier detection to facilitate early maintenance planning and is why the ii910 has a frequency range of 2-100Khz.

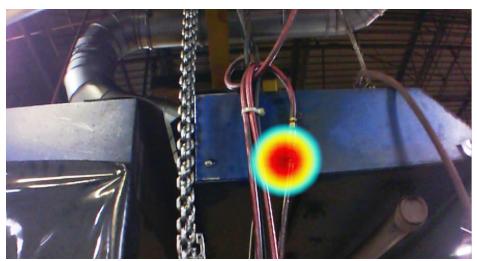
Image taken with the ii900 Industrial Acoustic Imager of an air leak in an industrial environment.

The ii900 series acoustic imagers let technicians see sound as they scan hoses, fittings, and connections for leaks. Its built-in acoustic array of tiny sensitive microphones generates a spectrum of decibel levels per frequency. Based on this output, an algorithm calculates a sound image, known as SoundMap $^{\text{TM}}$  that is superimposed on a visual image. The SoundMap is automatically adapted depending on the frequency level selected so that background noise is filtered out, making it incredibly simple to detect compressed gas leaks.
